Memorandum

From: CDM

Date: May 27, 2010

Subject: Final Technical Memorandum – Source Evaluation Activities in Carbon Canyon Creek and Cypress Channel

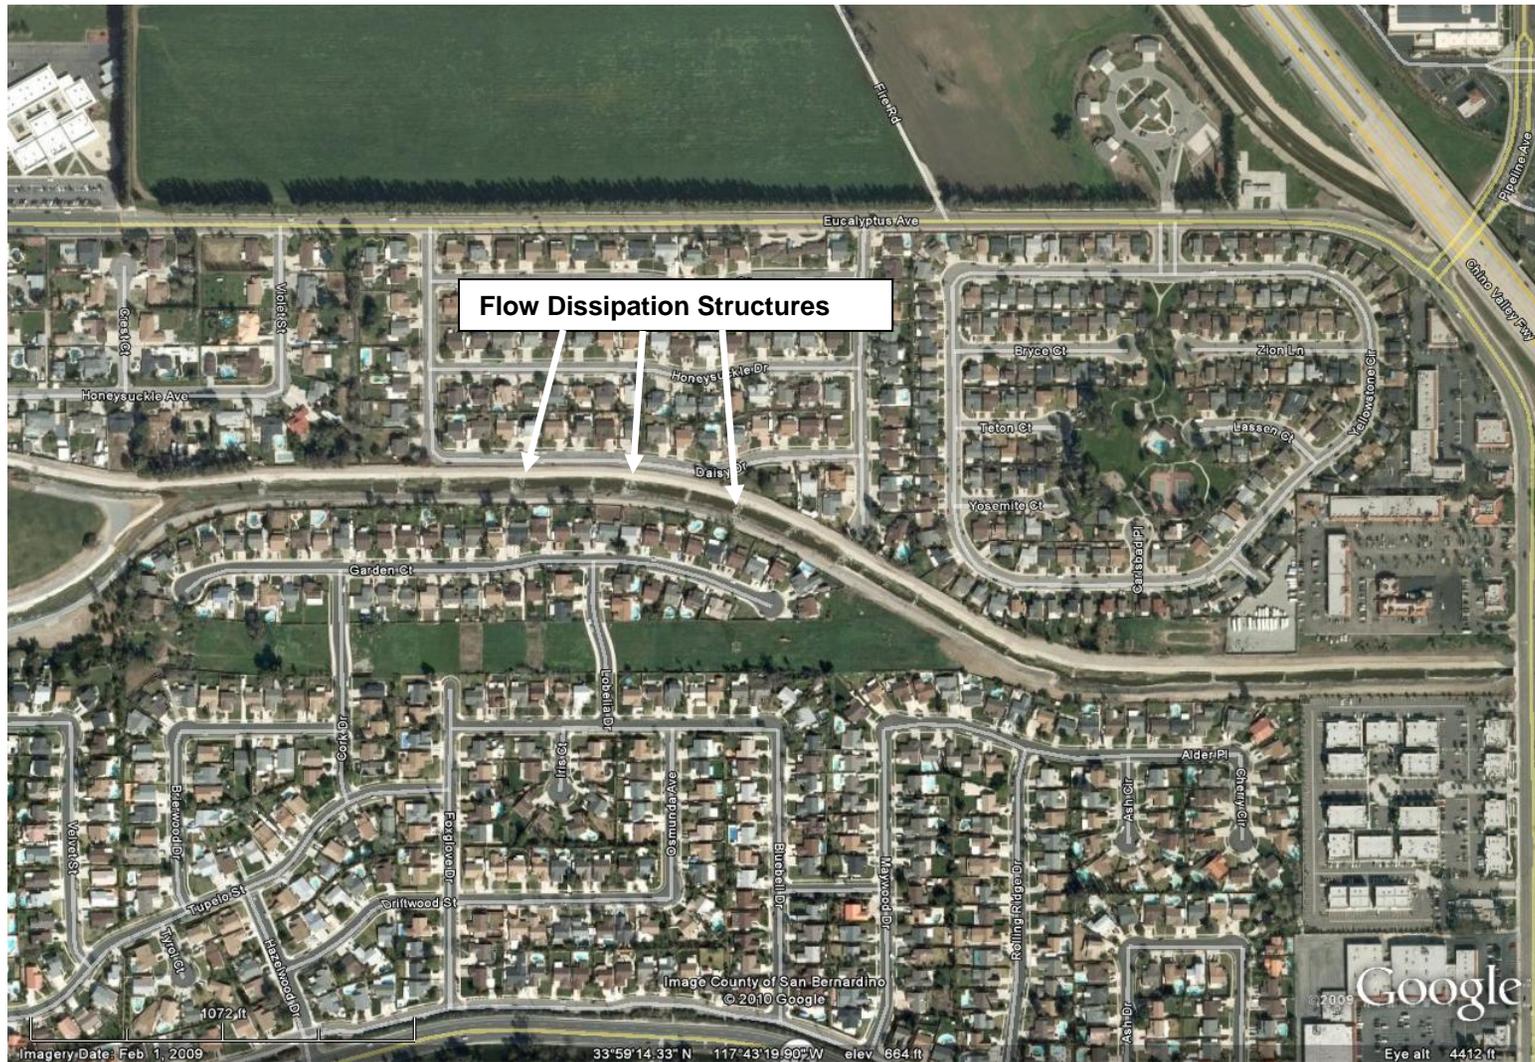
Figure 6. Flow dissipation structures in Carbon Canyon Creek (see Figure 5 for relative location within subwatershed)

dissipation structures facilitate sediment deposition resulting in pooled water and vegetation development. While certainly not designed to be a dry weather treatment BMP, these flow dissipation control structures may be providing unintended water quality benefits by (1) reducing flow rates, which increases opportunity for ultraviolet sunlight to kill bacteria; (2) providing a filtering effect as water slowly moves through each flow dissipation structure, and (3) increasing opportunity for vegetation pollutant uptake. It is possible that during dry weather this portion of the channel may be functioning like an extended detention basin or vegetated swale.

Given these observations, it is recommended that at some point the Task Force consider additional studies in this subwatershed to determine if the flow dissipation control structures are truly providing water quality benefits. Implementation of this recommendation would require a short-term intensive monitoring survey to evaluate FIB concentrations above, below and within the segment where the control structures are located. If these structures are providing water quality benefits, then this type of channel structure could be considered for other waterbodies as a potential BMP.

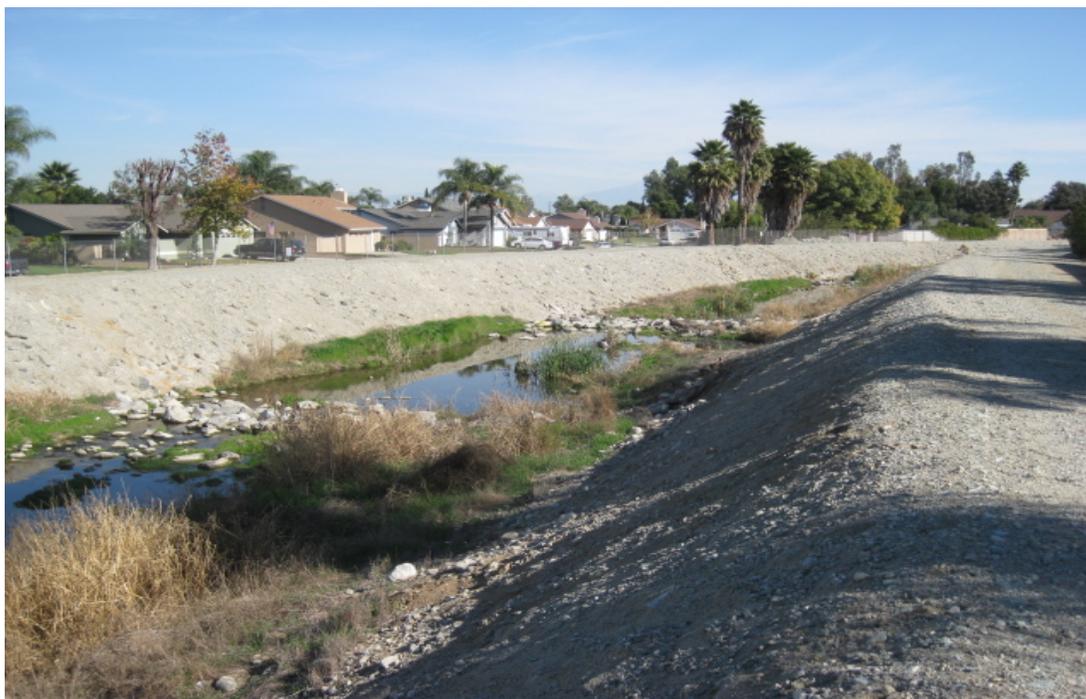
Vegetated growth was observed throughout the entire length of the trapezoidal concreted-rock segment of the channel (from approximately 750 feet east of Peyton Drive downstream to Pipeline Avenue). Vegetation was prevalent along the base of the side slopes. Additionally, more significant vegetation was observed from the English Canyon Channel confluence to Pipeline Avenue. The flow dissipation bottom control structures appear to facilitate sediment accumulation within the ponded areas which has led to increased vegetation growth.

Figure 7. Ground view of concreted-rock bottom control structures. Note vegetative growth and ponded water associated with structures.

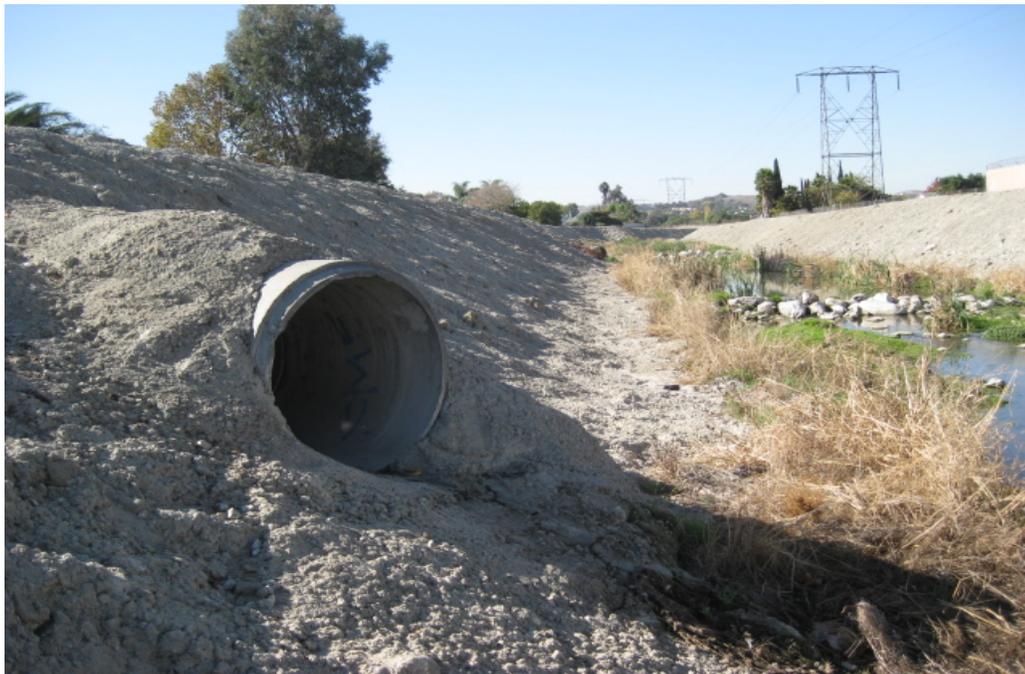
Figure 8. View of storm drain lateral to channel (no flow observed)

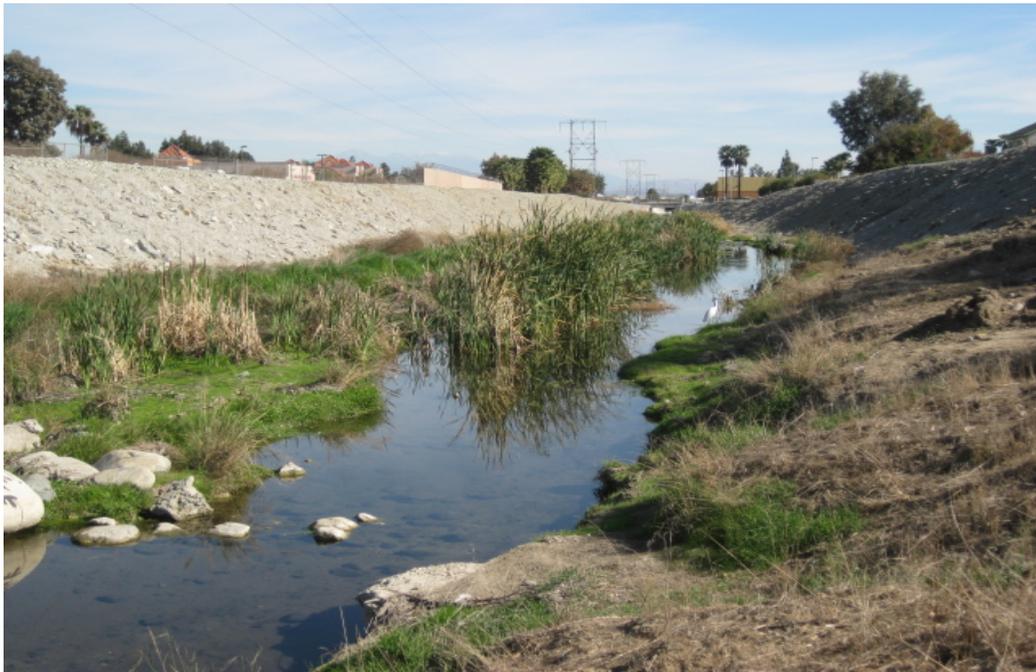
Figure 9. Downstream view of vegetation and ponded water within channel

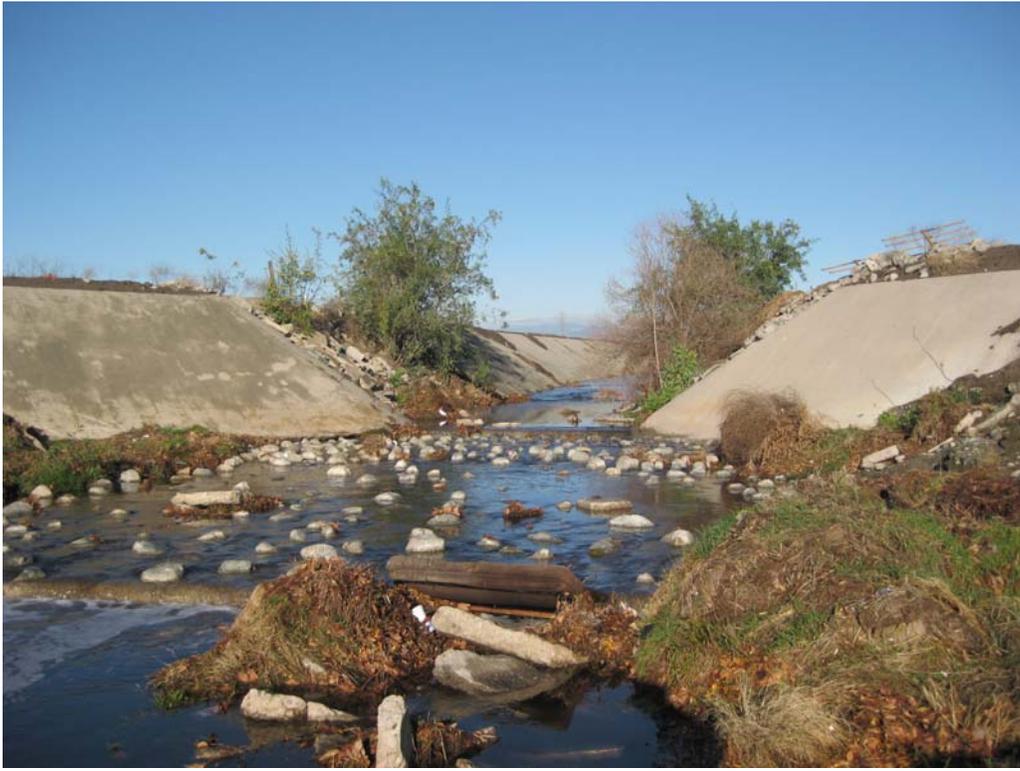
Figure 19. Upstream view of Cypress Channel (transition from trapezoidal concrete to natural) at CIM

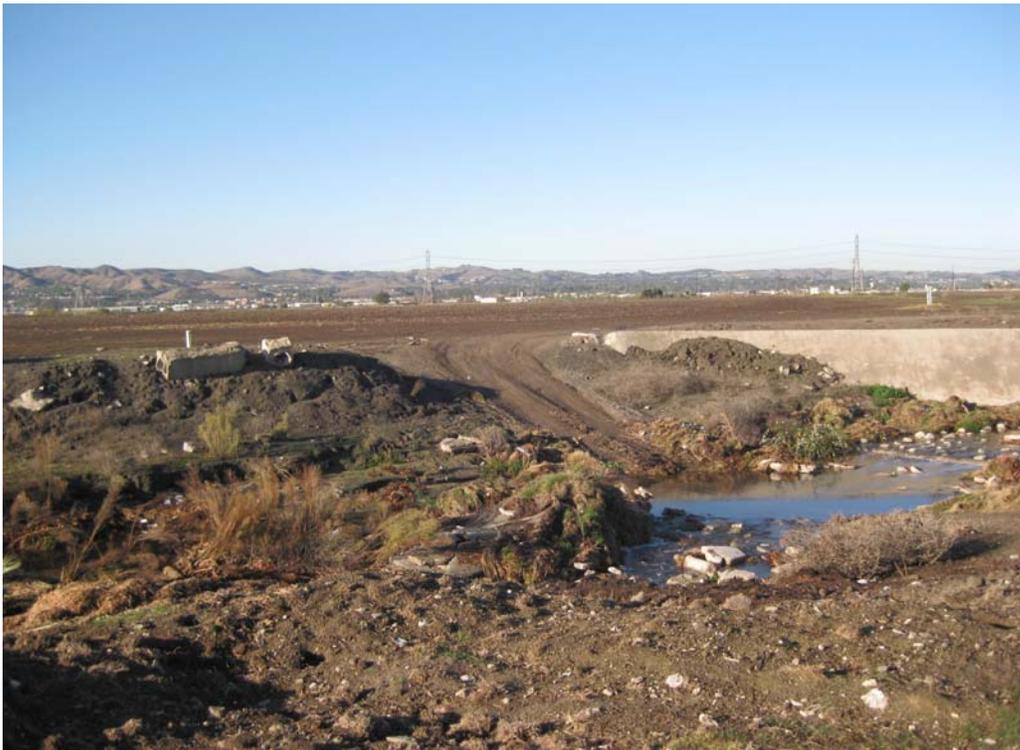
Figure 20. Unlined section of Cypress Channel within CIM; agricultural field in background with no buffer between field and channel

- CIM is not under the jurisdiction of the City of Chino, nor does SBCFCD have jurisdiction over Cypress Channel within CIM property. CDM recommends that the RWQCB follow-up with the CIM to evaluate BMPs implemented in agricultural fields adjacent to Cypress

Channel. For example, a wider buffer with accompanying BMPs (such as silt fencing, fiber rolls) could be implemented to prevent runoff from the agricultural fields from entering Cypress Channel. Limited BMPs (silt fencing) were visible along the natural earthen segment but these BMPs did not prevent sediment from sloughing into the channel. Without more BMPs in place, it appears that any runoff generated from agricultural fields likely will discharge directly into the channel.

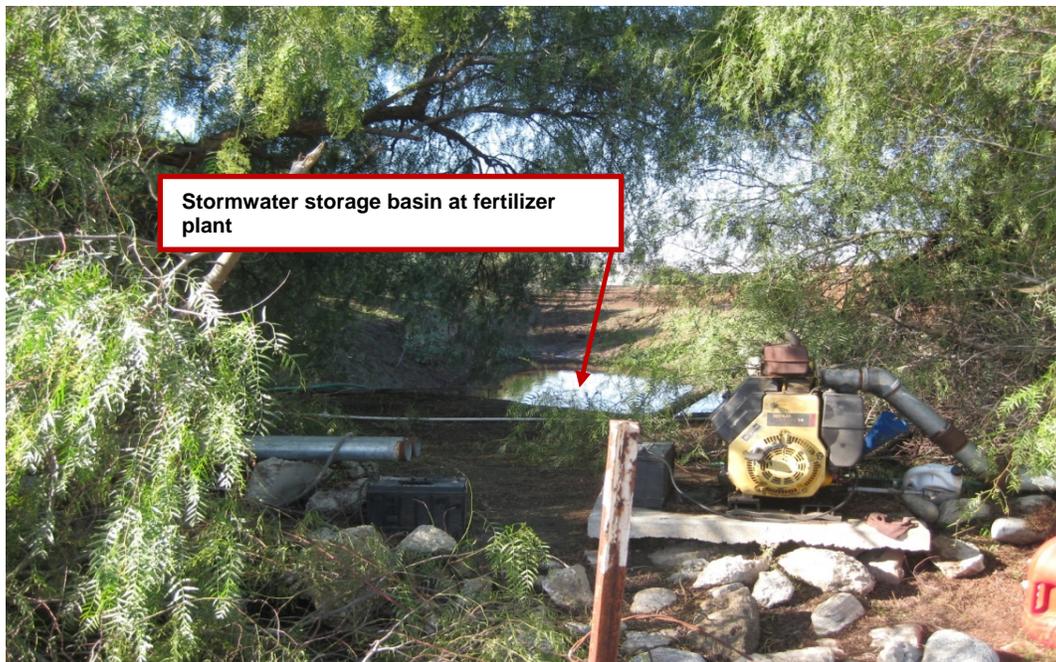
A fertilizer facility is located southeast of Kimball Avenue and Cypress Channel, downstream of the USEP monitoring location (see Figure 16). During the field reconnaissance, CDM observed a stormwater storage basin within the property of the fertilizer plant (see Figures 27 through 31). A pipe and pumping system was set up adjacent to the basin. Water was being pumped from the storage basin to a smaller bermed holding pond that was located within the plant's property line but close to the SBCFCD right-of-way. No direct connections were made to the channel and no discharges were observed leaving the fertilizer plant property. A lateral pipe in the channel is connected to a flared end section located within SBCFCD right-of-way but adjacent to the pumping system (see Figure 29). The purpose of this pipe is unclear.

Figure 27. Stormwater storage basin at fertilizer plant with pumping and piping equipment

CDM discussed with the City of Chino the observed conditions and the potential for overflow discharges to Cypress Channel if the pumping operations are not well-maintained. Subsequently, City staff inspected the facility and reported that collected stormwater runoff in the stormwater storage basin is pumped to the smaller holding pond temporarily before the water is pumped to a watering truck and used for on-site dust mitigation. City of Chino will continue to inspect this fertilizer facility. The City also reported that the facility had filed a Notice of Non-Applicability in 2008, indicating no stormwater discharges off-site of its facility. The Santa Ana Regional Water Quality Control Board (RWQCB) is in the process of making a determination on the filing (communications with Don Allinder, City of Chino, December 30, 2009 and February 4, 2010).

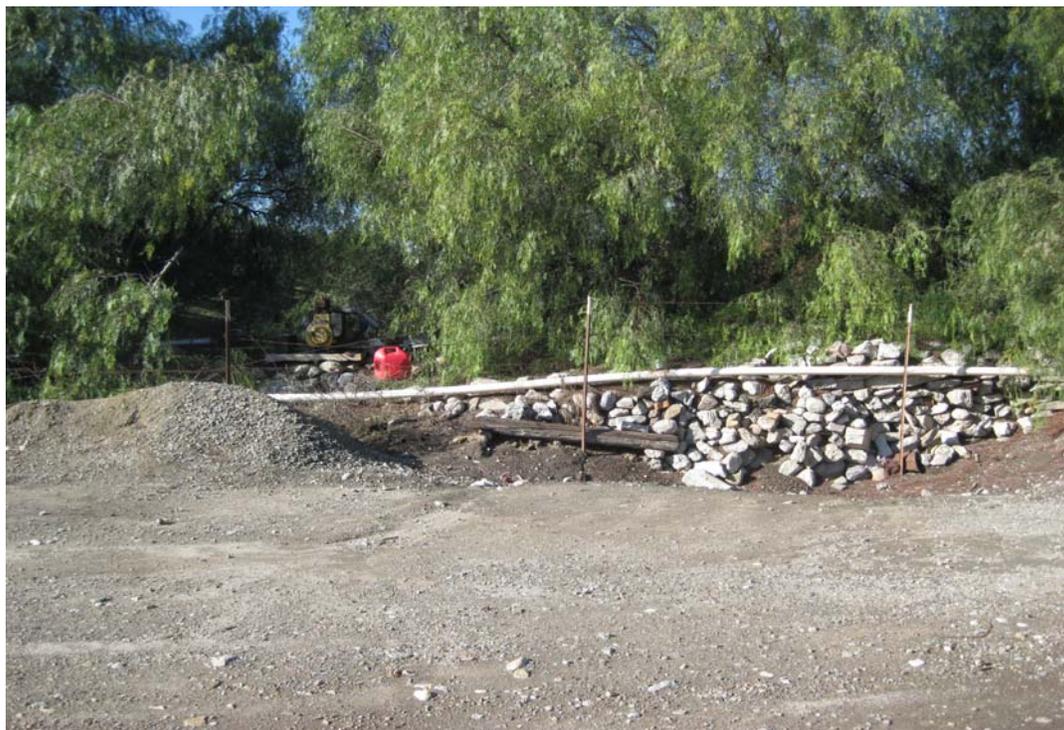
Figure 28. Broad view of piping and pump setup at fertilizer plant west of Cypress Channel

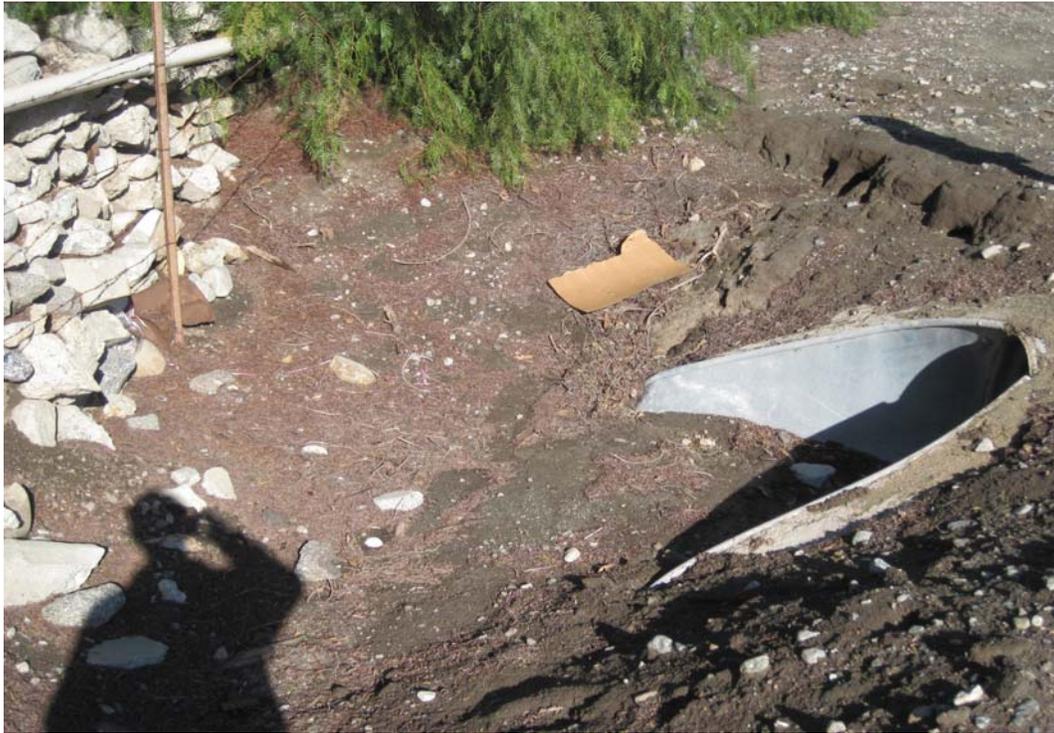
Figure 29. Culvert flared end section with 24-inch pipe located within SBCFCD right-of-way; pipe daylights to channel

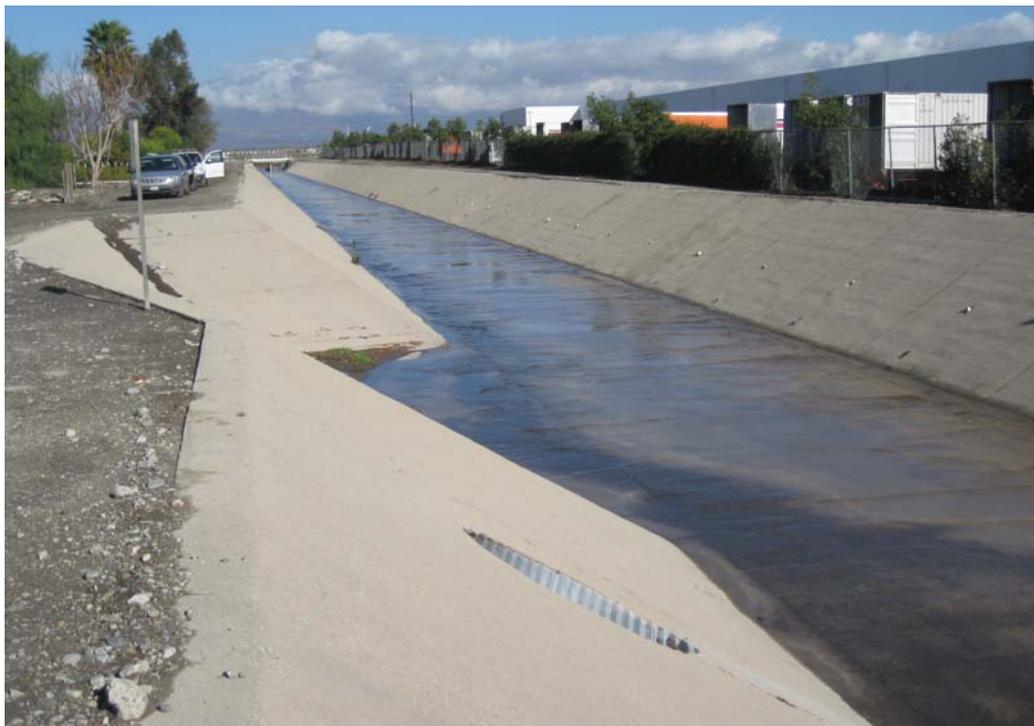
Figure 30. Lateral pipe (24") daylights to channel

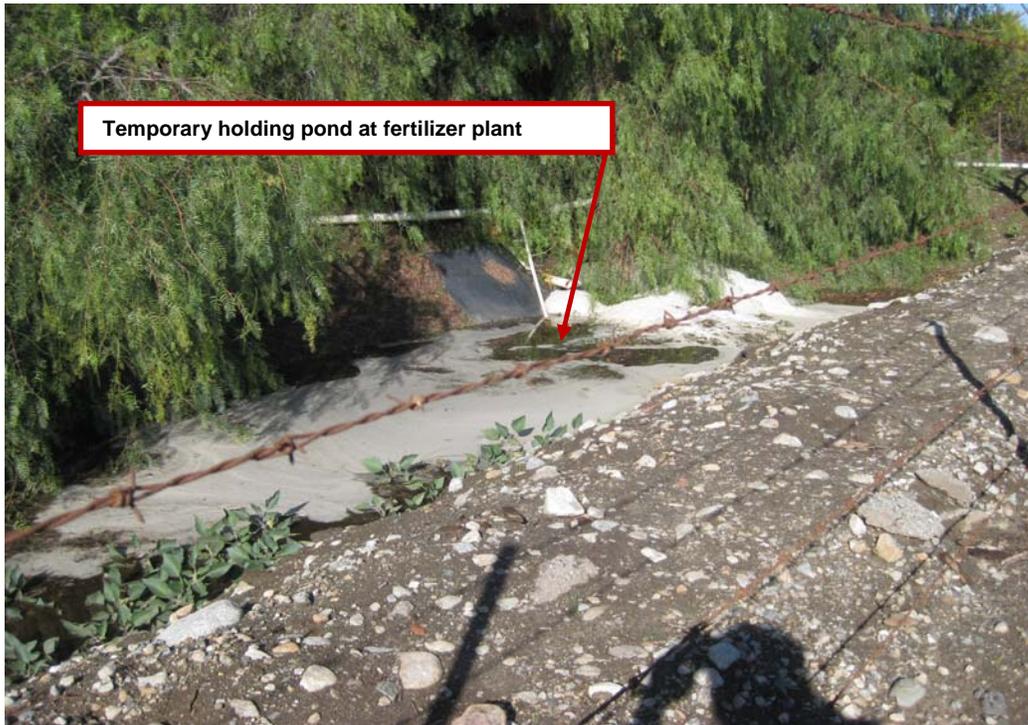
Figure 31. View of holding pond at fertilizer plant, adjacent to SBCFCD right-of-way (barbed wire fence)

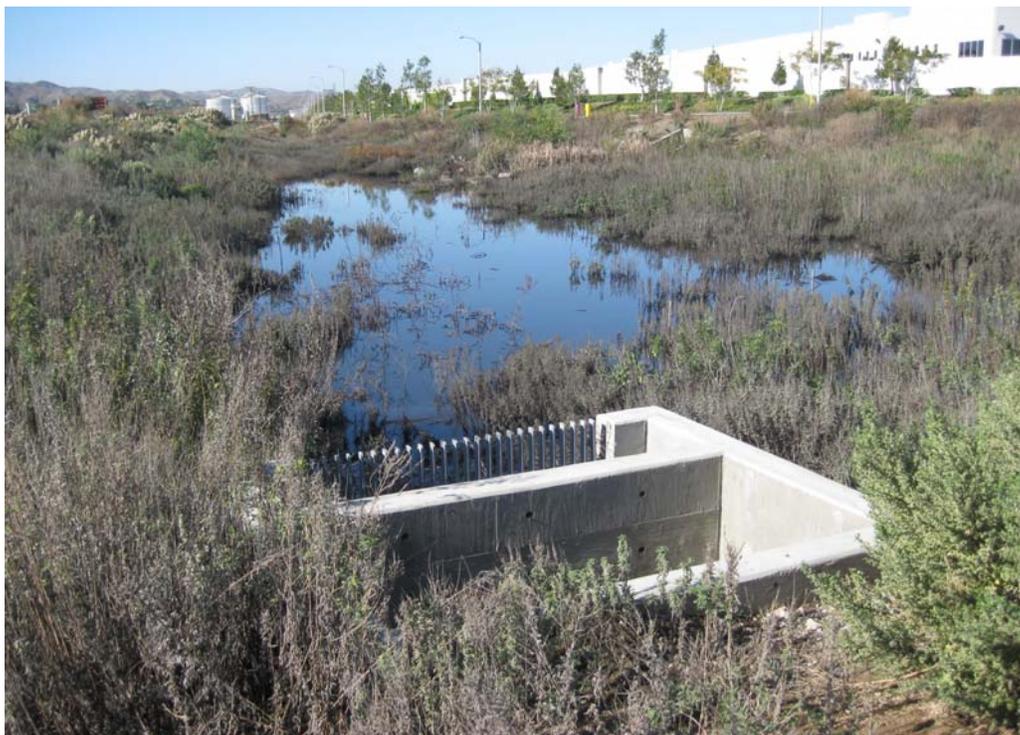
A detention basin designed to drain runoff from a commercial development is located downstream of Bickmore Avenue and Cypress Channel (also downstream of the USEP monitoring location, see Figure 16). This retention basin collects runoff from commercial properties located to the northwest of Bickmore Avenue and Cypress Channel. The detention basin, which was constructed as part of an approved Water Quality Management Plan, is believed to have been constructed in 2005 as part of the commercial/industrial development. The basin is designed to empty within 72 hours for vector control purposes (communication with Don Allinder, City of Chino, January 13, 2010). During the field survey, the basin was filled with water and actively discharging to Cypress Channel (Figures 32 and 33). Given the rain event the prior evening, this basin was operating as intended.

Figure 32. View of detention basin located to the southwest of Bickmore Avenue and Cypress Channel

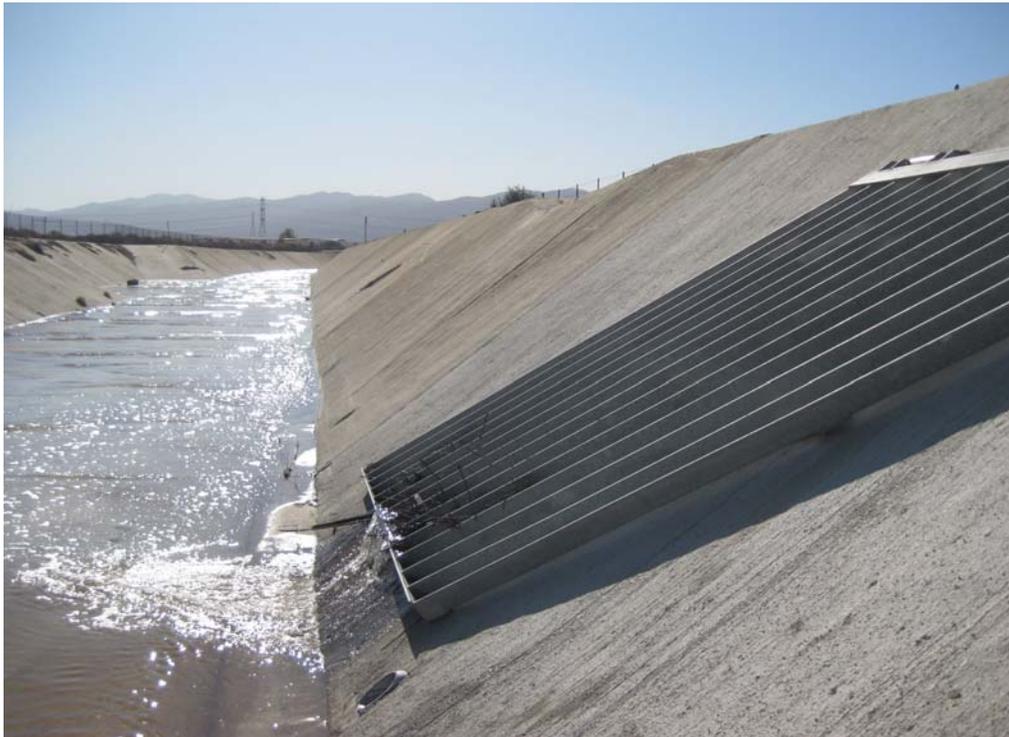
Figure 33. View of discharge entering channel from detention basin located to the southwest of Bickmore Avenue and Cypress Channel
