Technical Memorandum

Subject: Recreational Use Survey Data Report – Anza Channel

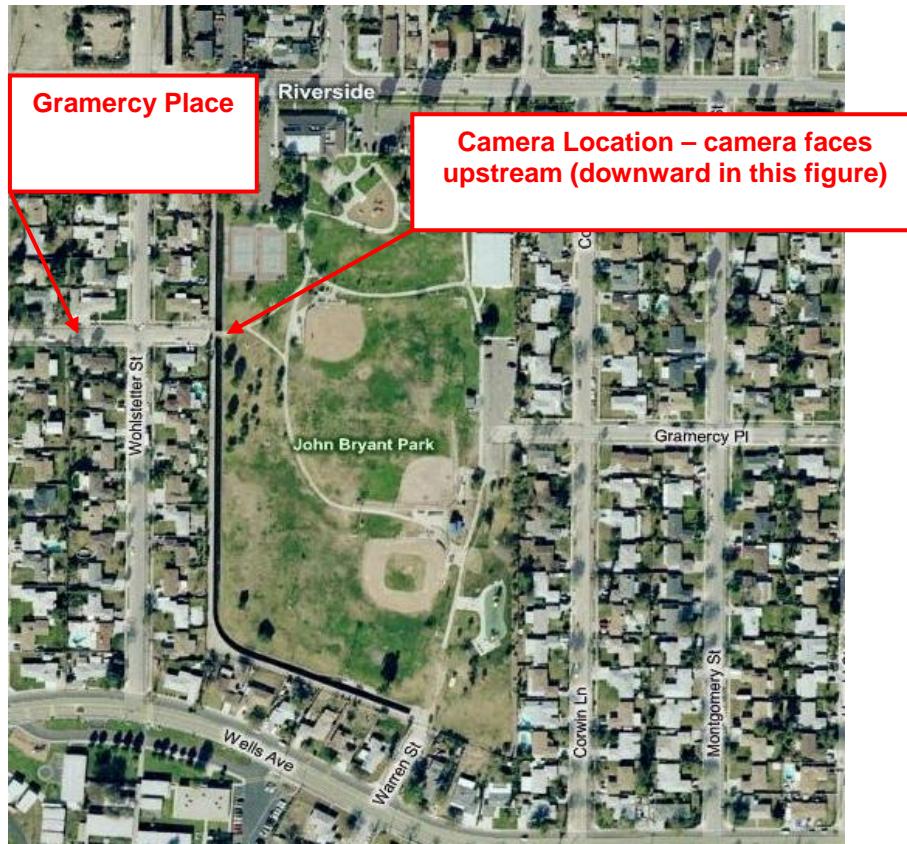
Figure 1
Anza Channel Survey Location

The location for this study was Anza Channel located near John Bryant Park in the City of Riverside. Figure 1 presents an aerial photo of the survey location. The predominant land use immediately surrounding the survey location is residential and open space. As shown in Figure 2, Anza Channel is a rectangular, concrete-lined channel.

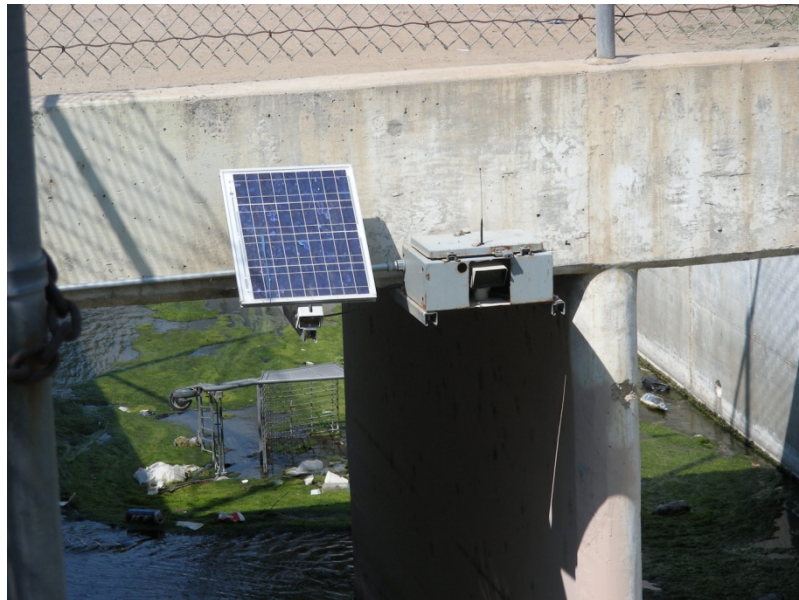
Figure 3
Photo of the Recreational Use Survey Camera Installation for Anza Channel

A camera with a solar panel was installed on the underside of the pedestrian foot bridge overcrossing Anza Channel, located east of Wohlstetter Street and Gramercy Place. Figure 3 shows the camera installation.

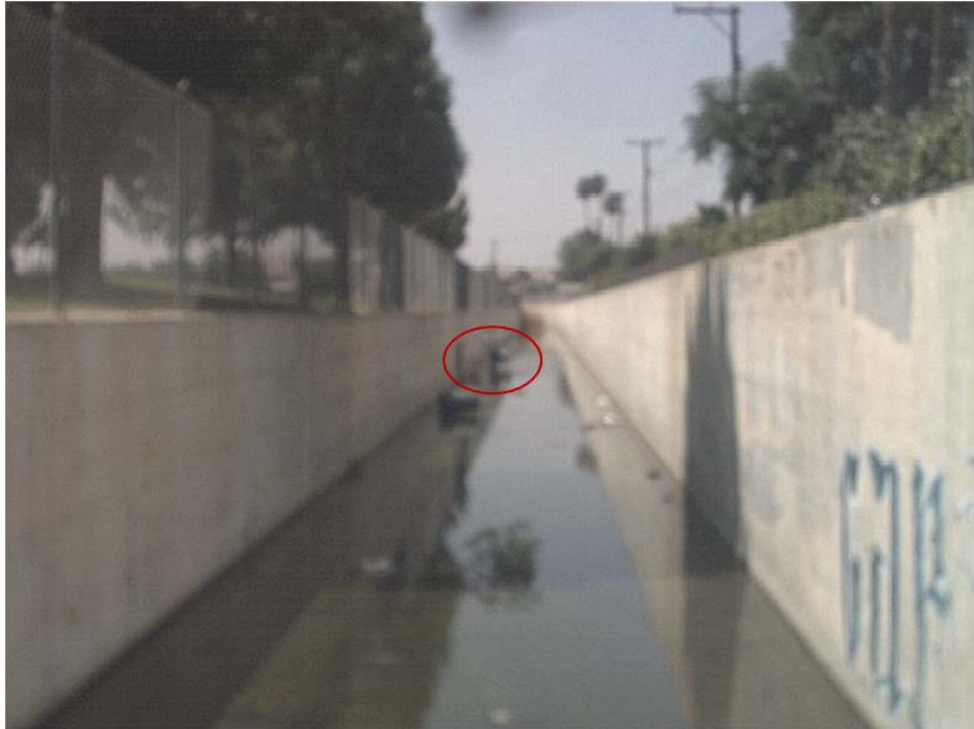
Table 3 Water Contact Recreation Events Recorded for the Anza Channel				
Date	Time	Duration (min)	Magnitude of Contact	Image ID
06/25/2009	11:15	< 30	Below Ankle	Anza_Drain_1-09-06-25-11-15.jpg
09/16/2009	12:00	< 30	Below Ankle	Anza_Drain_1-09-09-16-12-00.jpg

Water Contact Activity: 06/25/2009 11:15

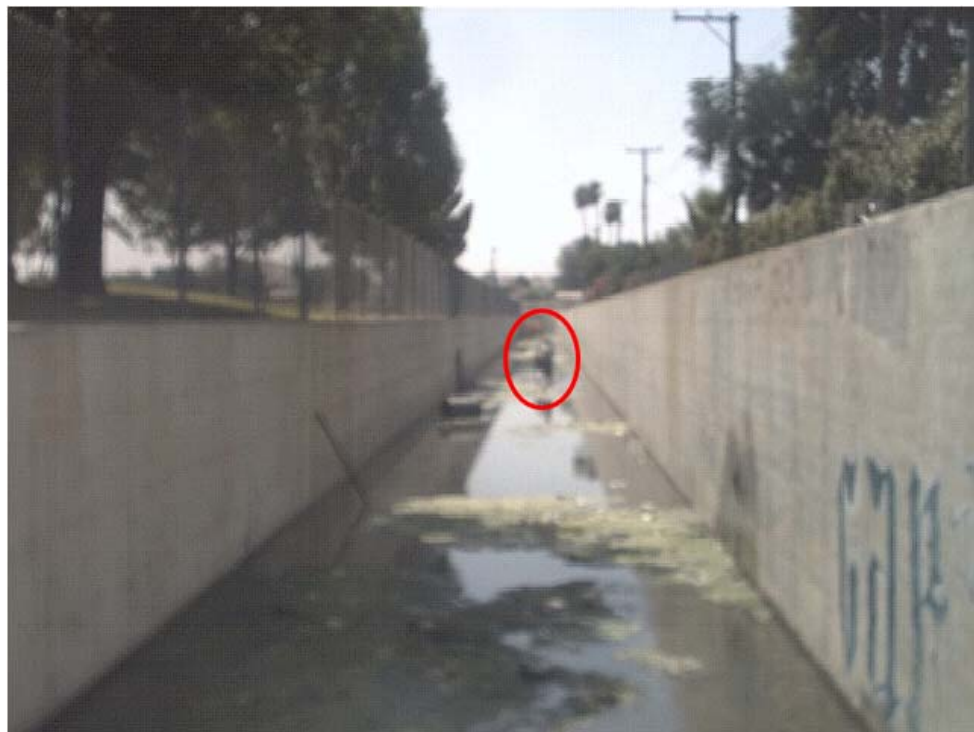
Water Contact Activity: 09/16/2009 12:00
