Technical Memorandum

To: Stormwater Quality Standards Task Force

From: CDM

Subject: Recreational Use Survey Data Report – Perris Valley Channel

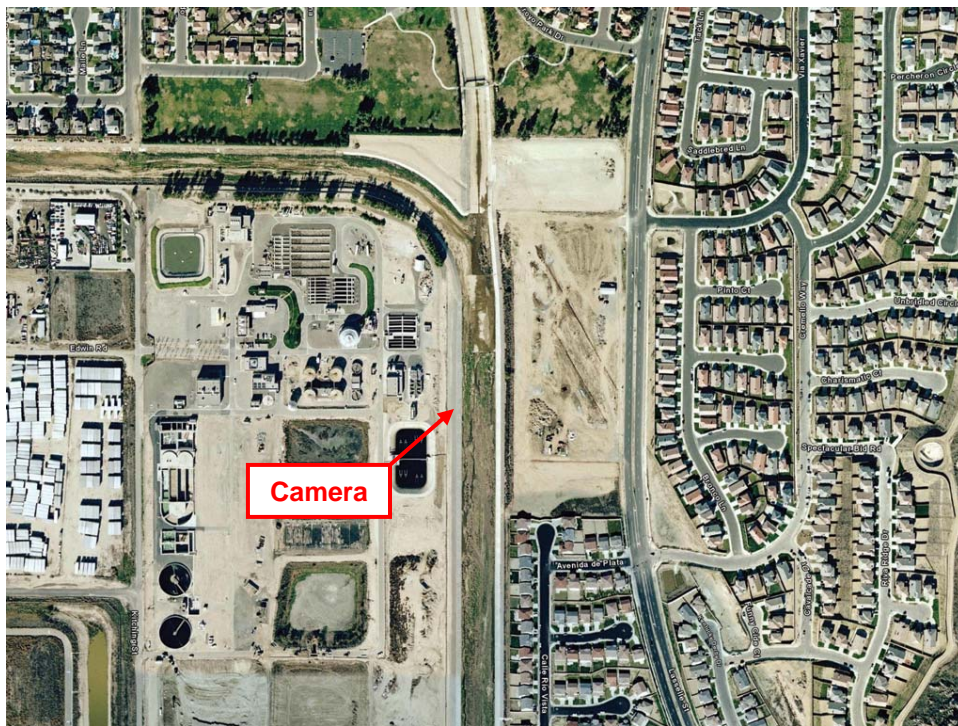
Figure 1
Perris Valley Channel Survey Location

The location for this study was Perris Valley Channel adjacent to the Eastern Municipal Water District (EMWD) Moreno Valley Regional Water Reclamation Facility, just south of El Potrero Park in the City of Moreno Valley. Figure 1 presents an aerial photo of the survey location. The predominant land uses immediately surrounding the survey location are residential and open space/public park. As shown in Figure 2, Perris Valley Channel is a trapezoidal channel with concrete side slopes and a channel bottom that transitions from a natural to a concrete bottom in the vicinity of the survey location.

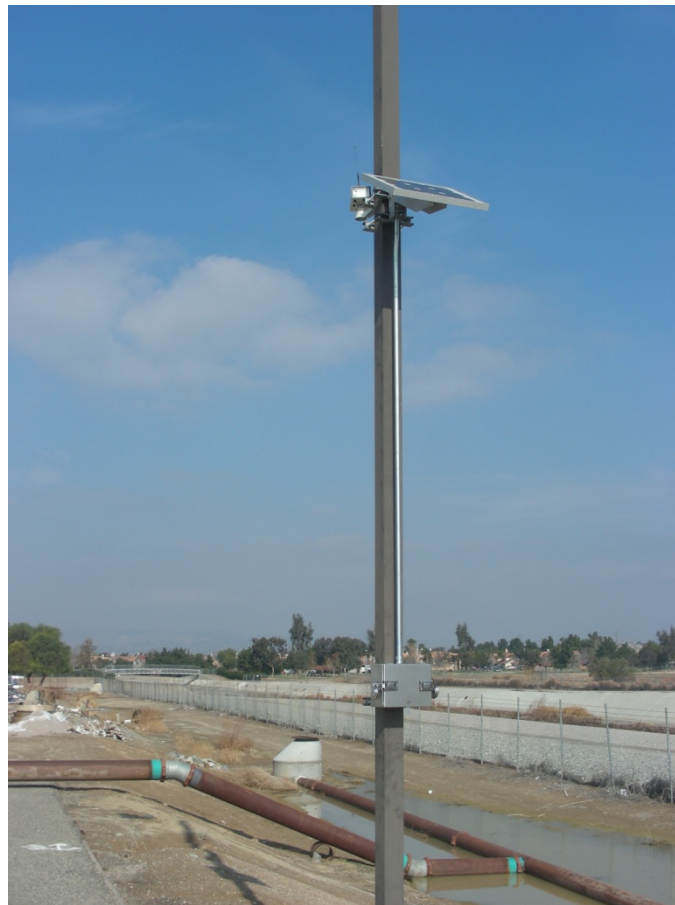
Figure 3
Photo of the Recreational Use Survey Camera Installation
for Perris Valley Channel

A camera was installed on a light pole at the EMWD Moreno Valley Water Reclamation Facility facing upstream on Perris Valley Channel. Figure 3 shows the camera installation.
