Technical Memorandum

Subject: Recreational Use Survey Data Report – Cucamonga Creek at RP1

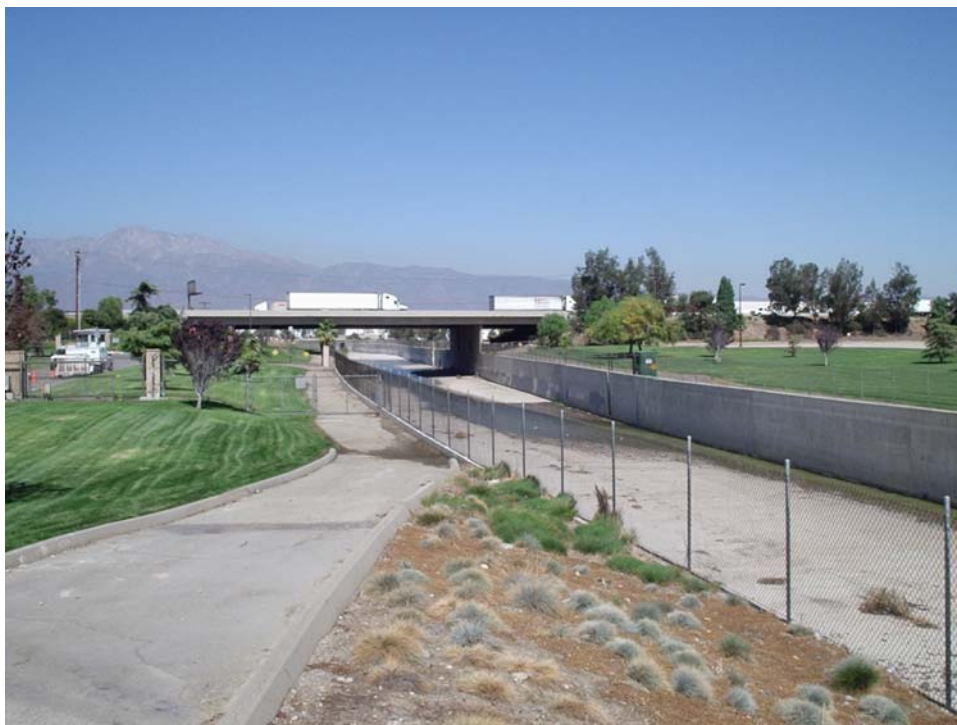
Figure 2
Photo of Cucamonga Creek at RP1 Survey Location

The location for this study was Cucamonga Creek adjacent to the RP1 grounds just south of the Pomona Freeway in the City of Ontario. Figure 1 presents an aerial photo of the survey location. The predominant land uses immediately surrounding the survey location are industrial/commercial and open space. As shown in Figure 2, Cucamonga Creek is a vertical walled, concrete lined channel in the vicinity of the survey location.

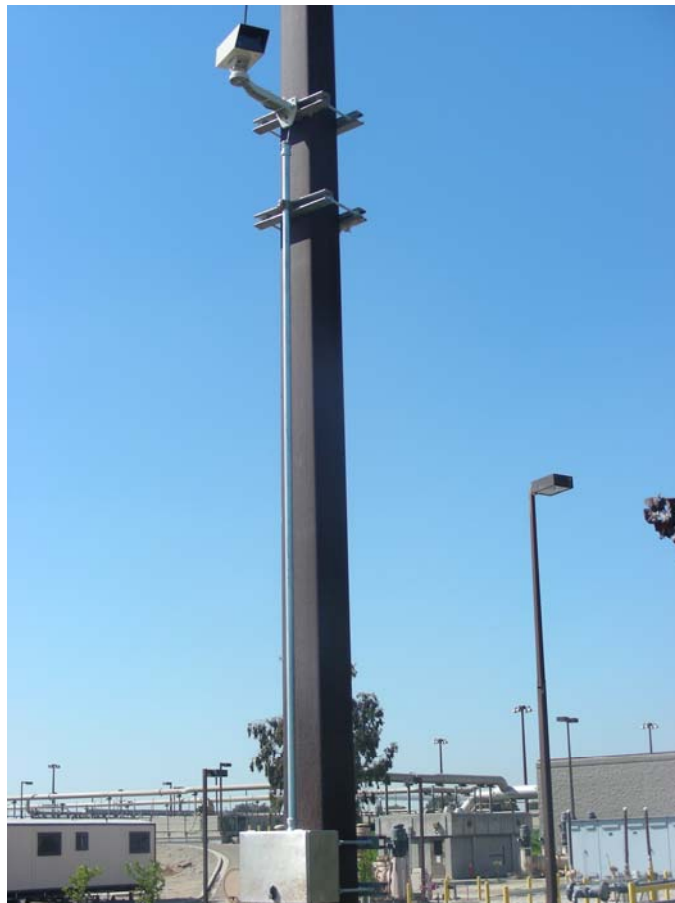
Figure 3
Photo of the Recreational Use Survey Camera Installation
for Cucamonga Creek at RP1

A camera was installed on a light pole at RP1 facing upstream on Cucamonga Creek. Figure 3 shows the camera installation.

Digital field observation cameras and data transfer technology, coupled with weekly on-location physical surveys were used to collect recreational use data. Observer IV™ cameras were equipped with cellular data transmission equipment to collect an image every fifteen minutes, and transfer the image to a secure data storage server via a file transfer protocol (FTP) site. Site visits were conducted to log recreational use observations, and to monitor and maintain the image collection equipment. This survey design was selected to provide unprecedented levels of data to characterize recreational use.
