A PICTURE IS WORTH A THOUSAND WORDS: USING WIRELESS VIDEO CAMERAS TO SUBCATEGORIZE RECREATIONAL USE DESIGNATIONS

Abstract: Wireless video cameras were installed in nine storm water channels to evaluate the potential for water contact recreation to occur in these locations. Cameras were programmed to collect one image every 15 minutes during daylight hours for twelve months. The resulting pictures were used as part of a Use Attainability Analysis to demonstrate that either no or only incidental, infrequent and partial body contact was occurring with no significant risk of immersion or ingestion. As a result, the associated stream segments are being recommended for reclassification which will result in the application of less stringent bacteria water quality criteria.

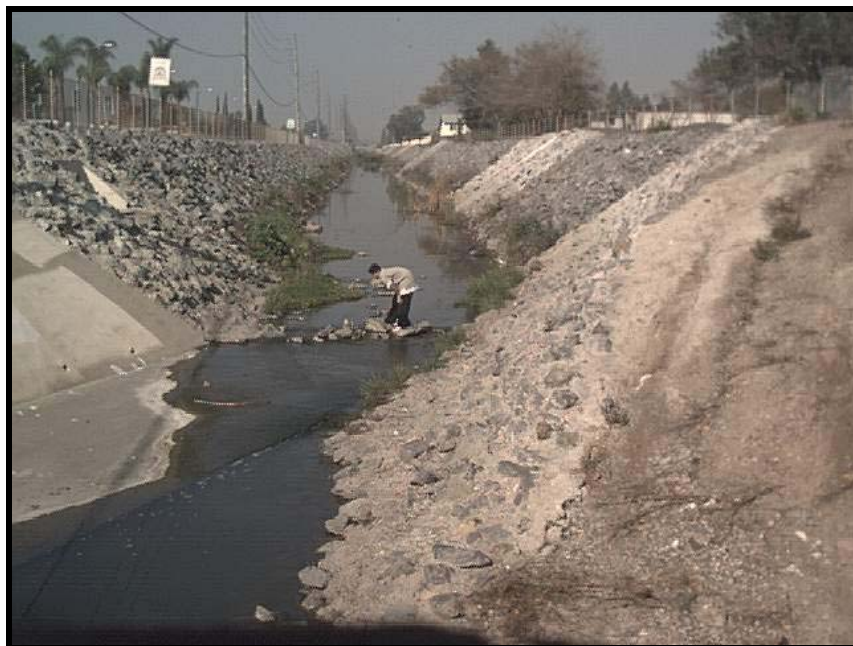
Fig. 2: Water Contact Recreation at Santa Ana Delhi Site #1

Figure 2 shows a picture of the only recreational water contact event observed at Site #1 (near the schoolyard). Despite the fact that the child is actually standing on a stone in the middle of the creek, it is difficult to infer that full body contact recreation is likely to occur or that there is a serious risk of immersion or significant ingestion.

Of the more than 63,000 photographs taken, representing nearly 16,000 hours of potential recreational opportunities, only three pictures (<0.005%) show anyone actually being in a position to ingest water, even accidentally. In one instance, a boy is standing on stones as he crosses over the creek (see Fig. 2 above). In another, the person is crouching on the stream bank washing their hands after lunch (see Fig. 7) or illegally boating in the nature preserve (see Fig. 8).

Moreover, even if each of the four people shown in Figures 2, 7 and 8 actually did fall in and ingest some water, the odds of contracting a gastrointestinal illness would still be quite remote. EPA's recommended water quality criteria for bacteria is based on the premise that approximately 1% of all persons exposed to the maximum allowable E. coli concentration are likely to become ill. If the actual E. coli concentration were ten times higher than the recommended criteria, then the expected illness rate would still be less than 2% of the exposed individuals (see Fig. 9). In a location such as the ocean beaches in Orange County, where people enjoy 30 million beach days annually, a 1% increase would result in tens of thousands of additional illnesses. However, in the stormwater channels where only a few people a year even come close to the water, it is unlikely that any illnesses are actually occurring.

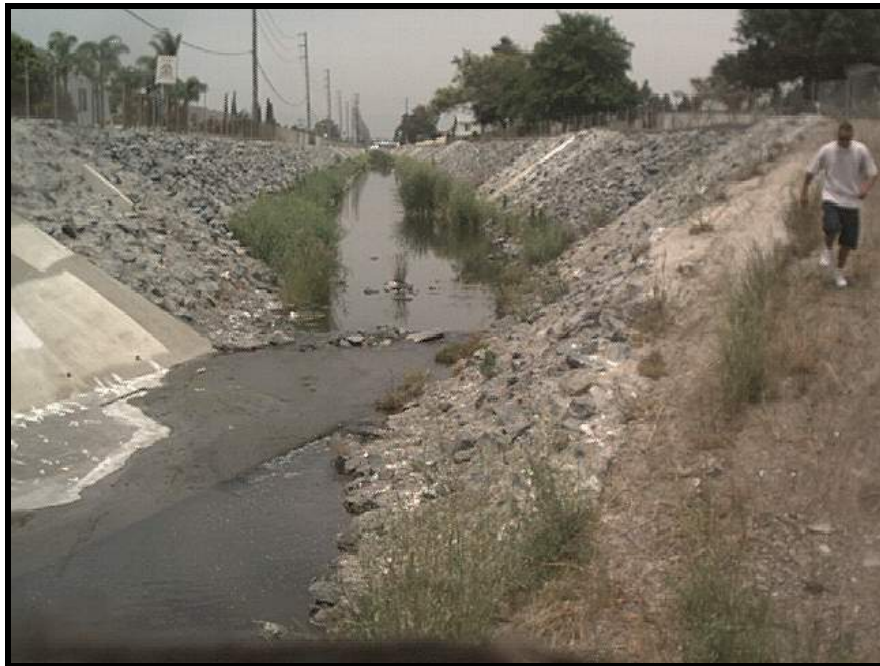
Fig. 3: Non-Contact Recreational Activity at Site #1

Figures 3 and 4 provide illustrations of typical non-contact recreational activities (e.g. walking) that occurs in shallow stormwater channels like the Santa Ana Delhi.

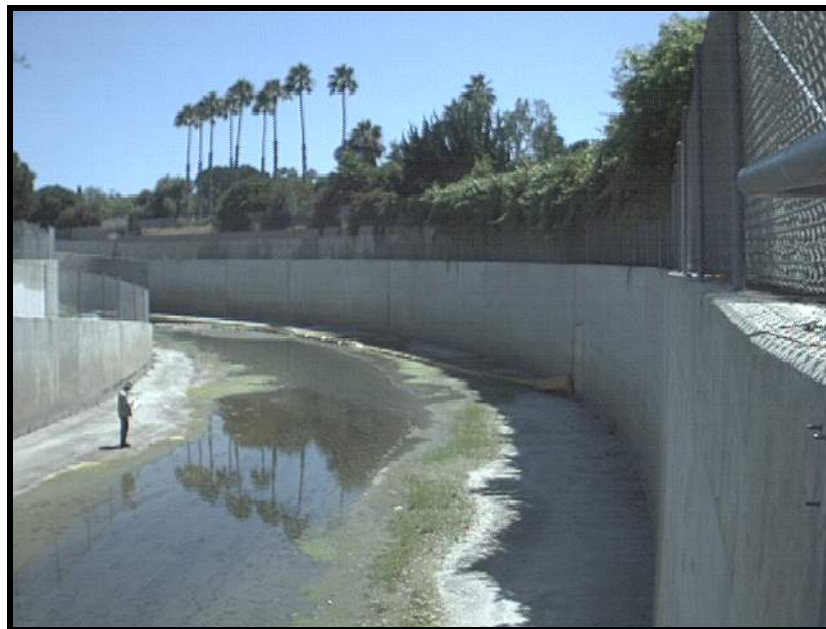
Fig. 5: Santa Ana Delhi Channel at Mesa Road in Orange County, California

Figure 5 shows a picture of the concrete-lined flood control channel at Site #2. The person shown in the picture is a member of the study team and helps provide a sense of scale.

The second camera was located in a large concrete-lined flood control channel approximately one mile downstream from the first camera. The channel is characterized by 20-foot high vertical walls and is difficult to access without first scaling well-maintained chain link fences. The channel is adjacent to a golf course and park. Average stream flow during the warm weather months is less than two inches deep with significant amounts of algae present.

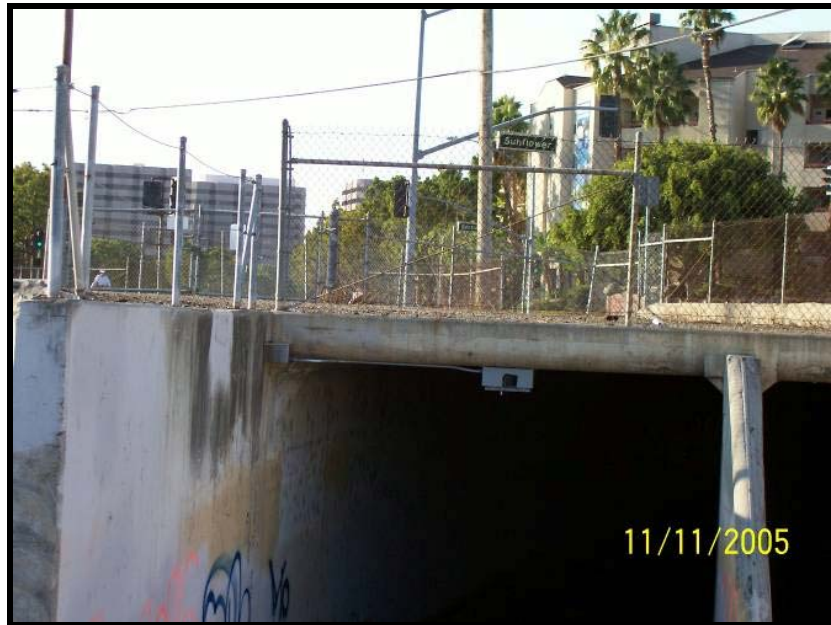
Fig. 6: Wireless Video Camera Mounted Under Bridge at Site #1 (Sunflower Ave.)

All of the pictures in Figures 2 thru 5 are actual images collected and transmitted by the wireless video cameras installed for the UAA study. Figure 6 shows the camera installed at Site #1.

Wireless video cameras were installed in each location. The automated cameras were programmed to collect one image every 15 minutes (during daylight hours) for one year. Pictures were transmitted to a central server over a cellular internet connection. Technicians made weekly visits to service and maintain the equipment. Some of the problems encountered included: powering the cameras, assuring adequate cellular signal strength, and protecting
