Technical Memorandum

Subject: ***Recreational Use Survey Data Report – Demens Channel***

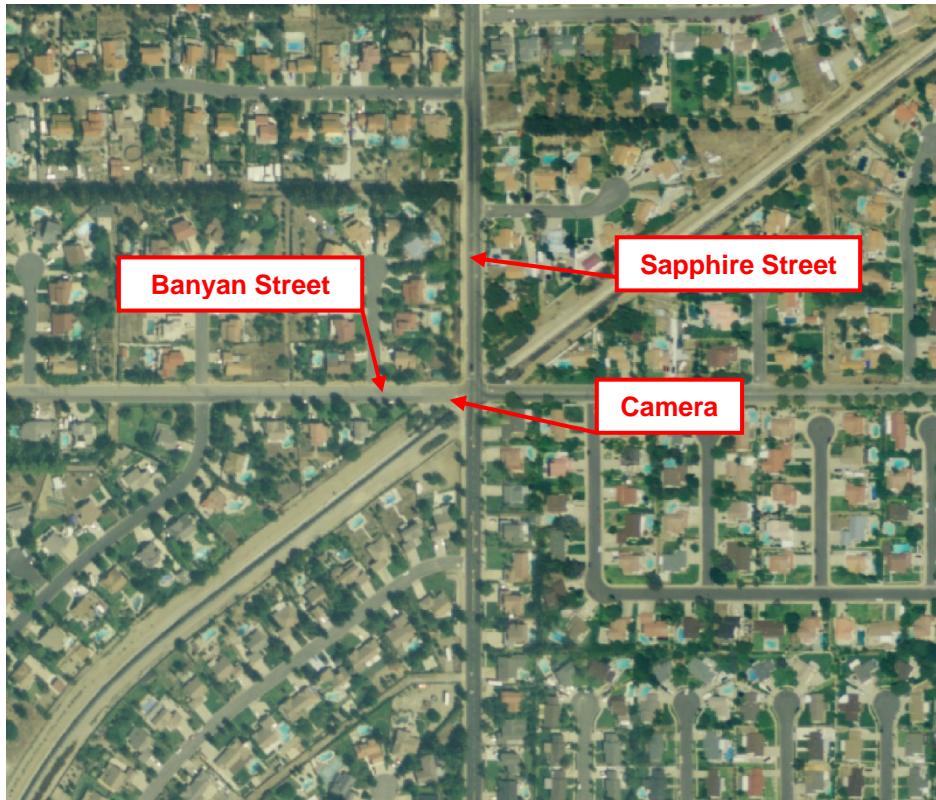
Figure 1
Demens Channel Survey Location

The location for this study was Demens Channel located downstream of the intersection of Banyan Street and Sapphire Street in the City of Rancho Cucamonga. Figure 1 presents an aerial photo of the survey location. The predominant land use immediately surrounding the survey location is residential. As shown in Figure 2, Demens Channel is a vertical walled, concrete lined channel in the vicinity of the survey location.

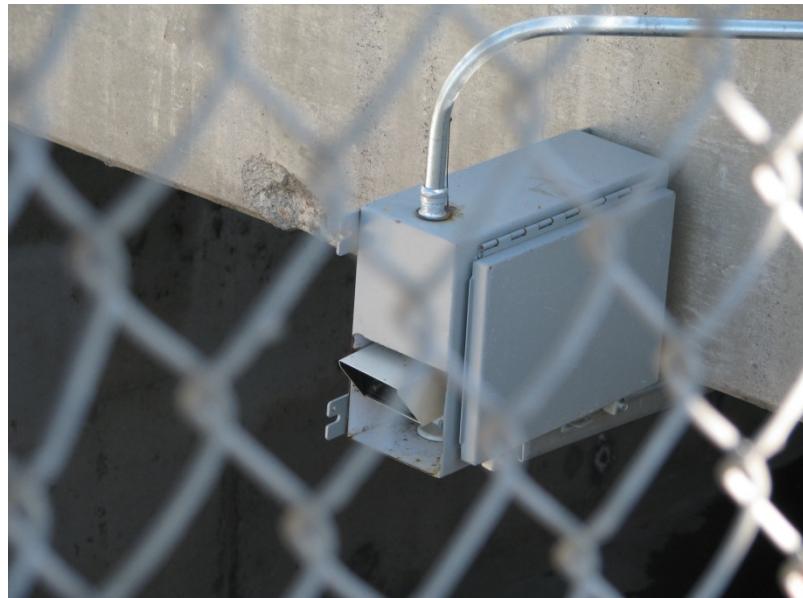
Figure 3
Photo of the Recreational Use Survey Camera Installation for Demens Channel

A camera was installed at the intersection of Banyan Street and Sapphire Street where the Sapphire Street bridge crosses over Demens Channel. Figure 3 shows the camera installation.

Digital field observation cameras and data transfer technology, coupled with weekly on-location physical surveys were used to collect recreational use data. Observer IV™ cameras were equipped with cellular data transmission equipment to collect an image every fifteen minutes, and transfer the image to a secure data storage server via a file transfer protocol (FTP) site. Site visits were conducted to log recreational use observations, and to monitor and maintain the image collection equipment. This survey design was selected to provide unprecedented levels of data to characterize recreational use.
