Memorandum

From: CDM

Date: May 27, 2010

Subject: Final Technical Memorandum – Source Evaluation Activities in Carbon Canyon Creek and Cypress Channel

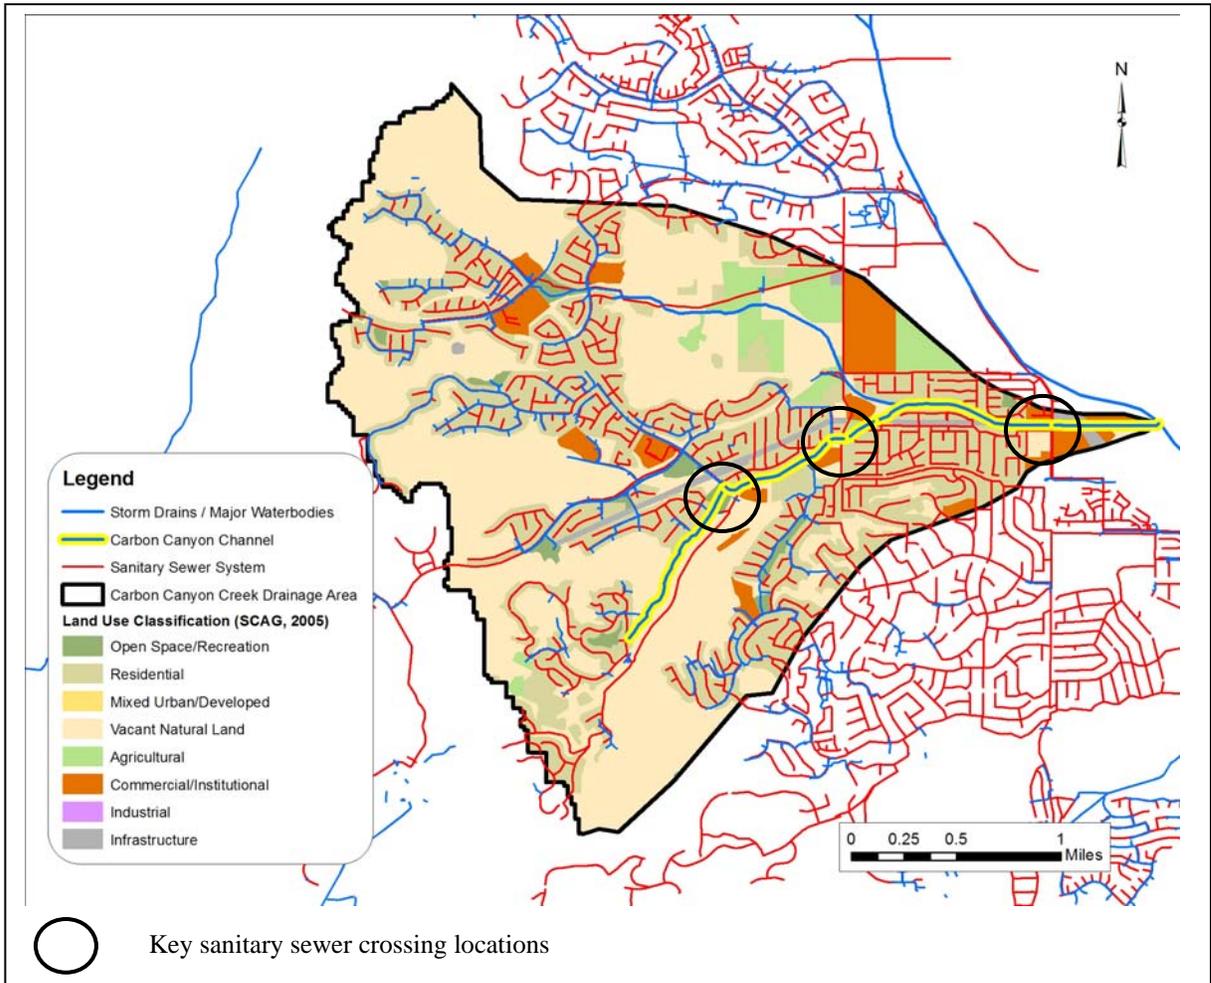
Figure 3. Sanitary sewer and storm sewers in the Carbon Canyon Creek subwatershed

The City of Chino Hills provided GIS data for the storm drain system within the Carbon Canyon Creek subwatershed. The provided storm drain network data are very high level, showing only major drainage inputs into the channel, not the smaller lateral drains entering the channel (Figure 3 - blue lines). The provided information did not include detailed data such as the number and size of lateral drains. During the field reconnaissance, there were no observed illicit connections to the channel.

Based on available GIS data, Figure 3 illustrates the location of sanitary sewer lines in the Carbon Canyon Creek subwatershed. Sanitary sewer lines are located belowground and typically cross channels at street/bridge overcrossings. Figure 3 highlights key areas where sanitary sewer lines intersect or are adjacent to the creek channel. Field reconnaissance was performed from outside the channel along the flood control right-of-way and not from within the channel, which limited the ability to view sanitary sewer line crossings, e.g., under bridges. Based on observations, no obvious signs of sanitary sewer line leaks were observed.

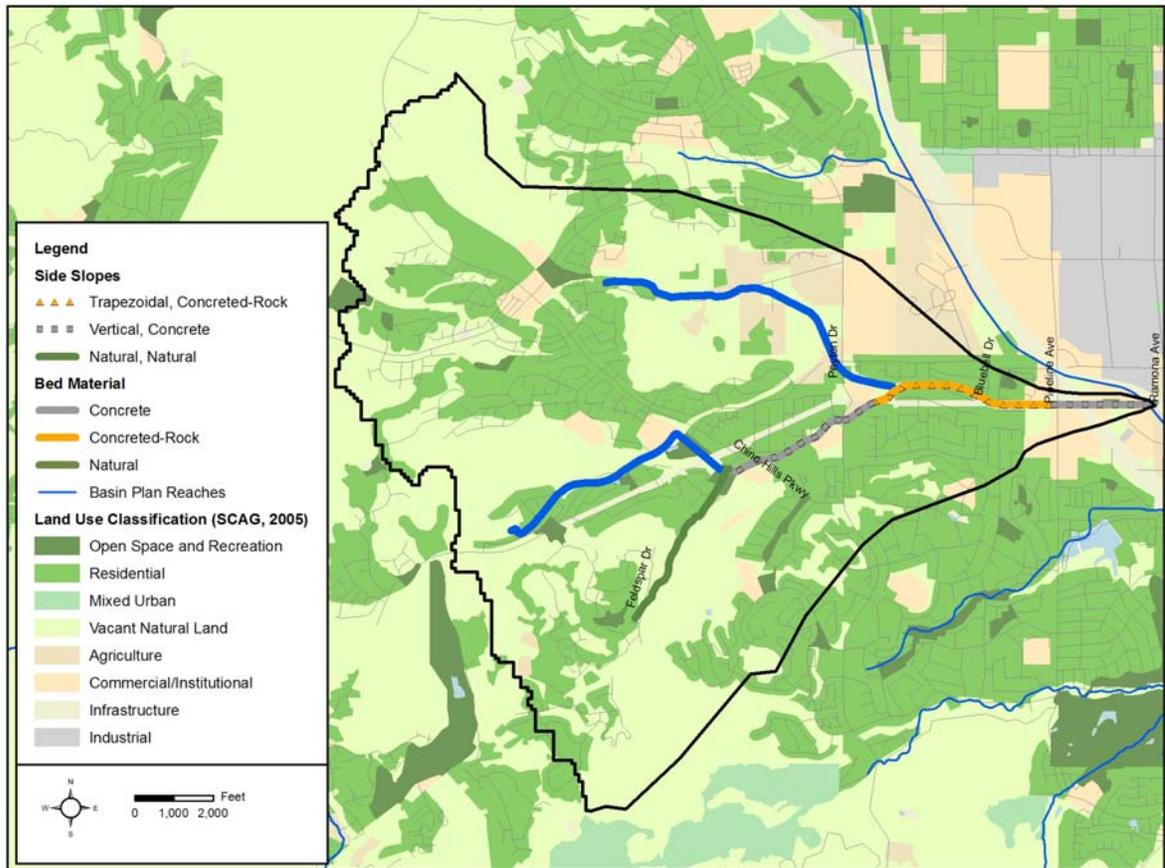
Figure 4. Carbon Canyon Creek channel characteristics

Vegetated growth was observed throughout the entire length of the trapezoidal concreted-rock segment of the channel (from approximately 750 feet east of Peyton Drive downstream to Pipeline Avenue). Vegetation was prevalent along the base of the side slopes. Additionally, more significant vegetation was observed from the English Canyon Channel confluence to Pipeline Avenue. The flow dissipation bottom control structures appear to facilitate sediment accumulation within the ponded areas which has led to increased vegetation growth.

This survey also identified reaches of Carbon Canyon Creek where Use Attainability Analyses (UAAs) could be developed. Specifically, these UAAs would be developed in the engineered portions of the channel (see Figure 4). At this time, the priority for these UAAs is low given the USEP monitoring program observation of low FIB concentrations during dry weather is low.

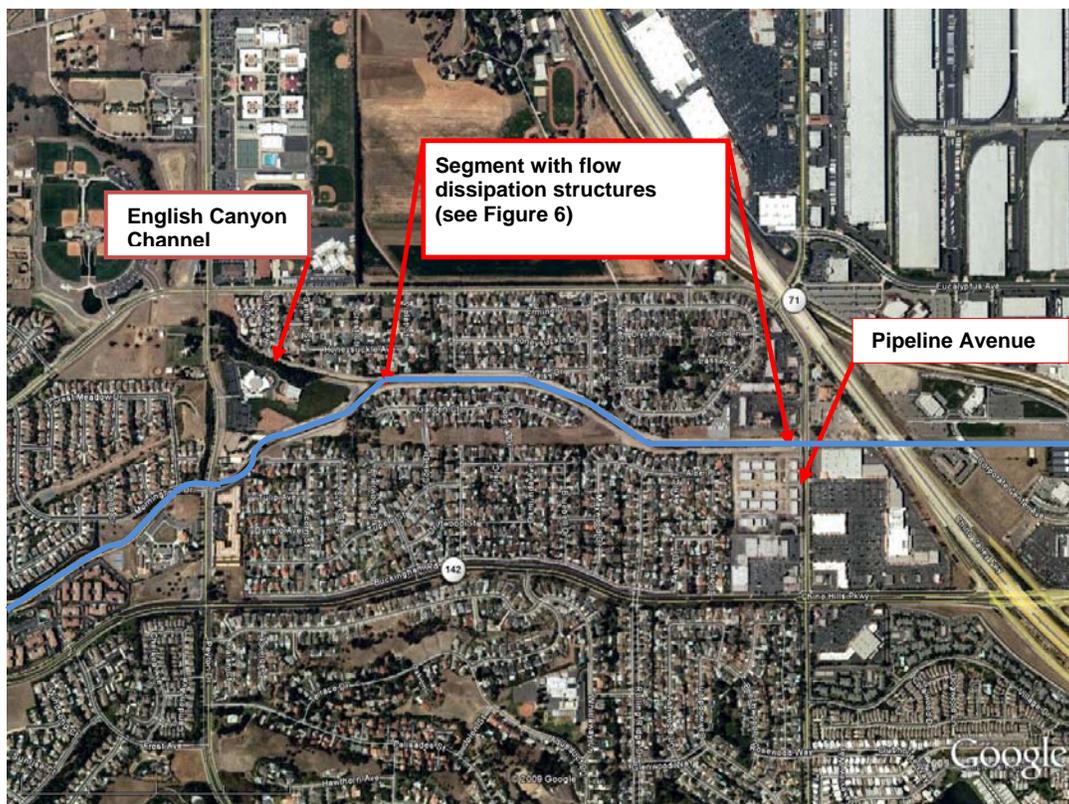
Figure 5. Aerial view of lower portion of Carbon Canyon Creek (blue line) segment showing location of concreted-rock bottom control structures

Figure 5 provides an aerial view of Carbon Canyon Creek from the confluence with English Canyon Channel downstream to Pipeline Avenue. This segment of the channel is believed to have a somewhat unique bottom structure. The channel has a concreted-rock side slope and bottom - a common type of construction. However, the channel bottom has a series of concreted-rock bottom control structures spaced approximately 150 to 200 feet apart (see close-up in Figure 6). Record drawings provided by SBCFCD indicate these structures are designed for flow dissipation. At the time of the field survey, the bottom control structures appeared to not be optimally maintained, resulting in pools of water behind each control structure along the length of this channel segment (Figure 7).

Given these observations, it is recommended that at some point the Task Force consider additional studies in this subwatershed to determine if the flow dissipation control structures are truly providing water quality benefits. Implementation of this recommendation would require a short-term intensive monitoring survey to evaluate FIB concentrations above, below and within the segment where the control structures are located. If these structures are providing water quality benefits, then this type of channel structure could be considered for other waterbodies as a potential BMP.

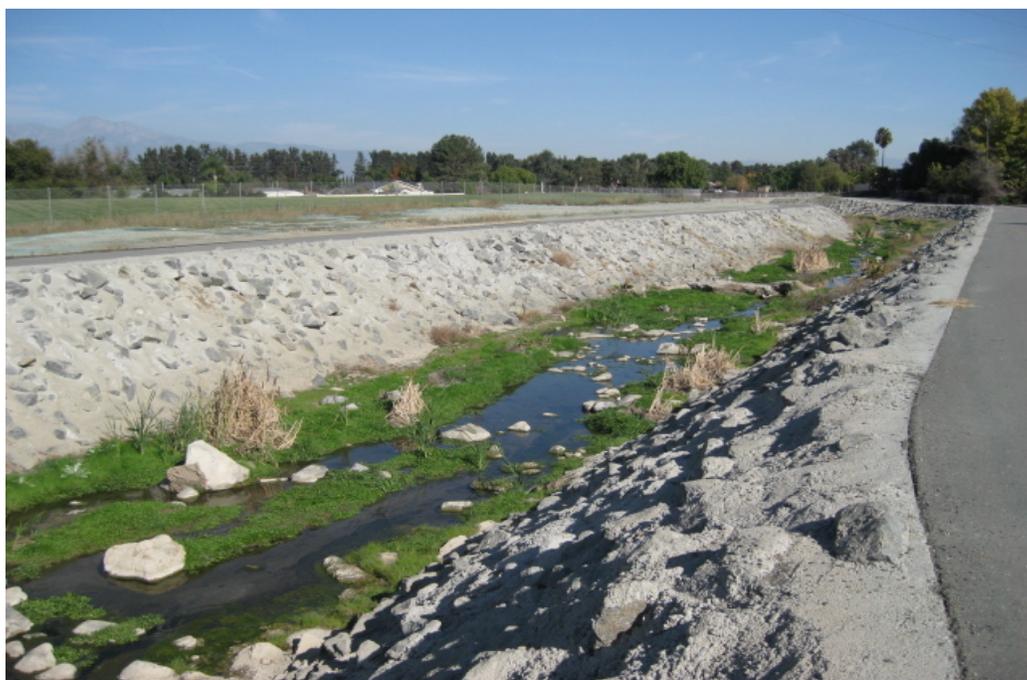
Figure 10. Typical downstream view of Carbon Canyon Creek upstream of confluence with English Canyon Channel

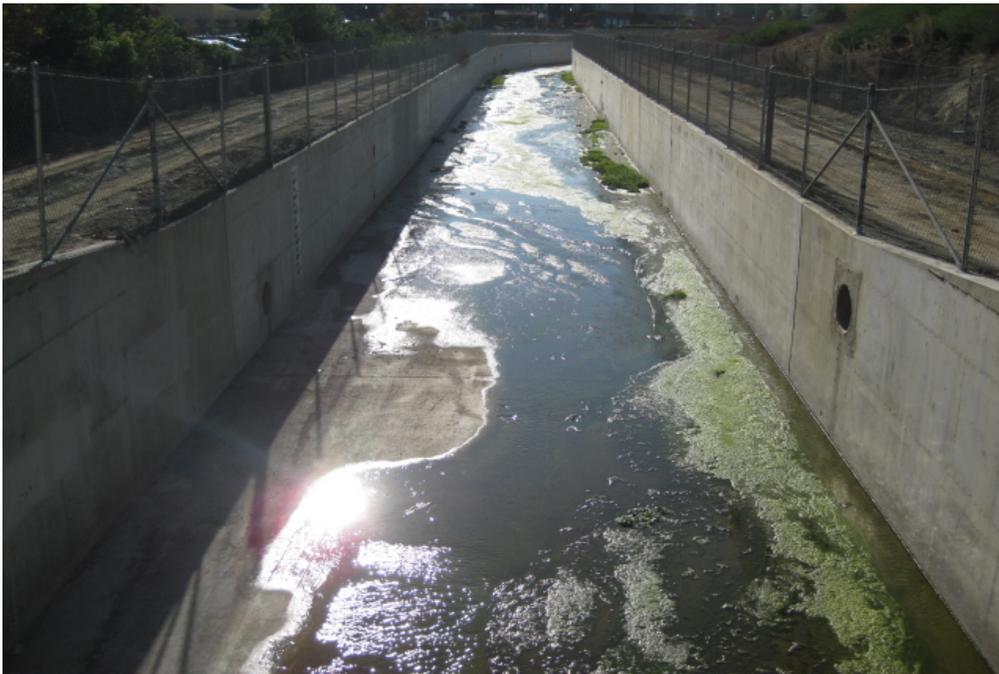
Figure 11. Upstream view of vertical concrete-lined channel near Morningfield Drive, upstream of English Canyon Channel confluence

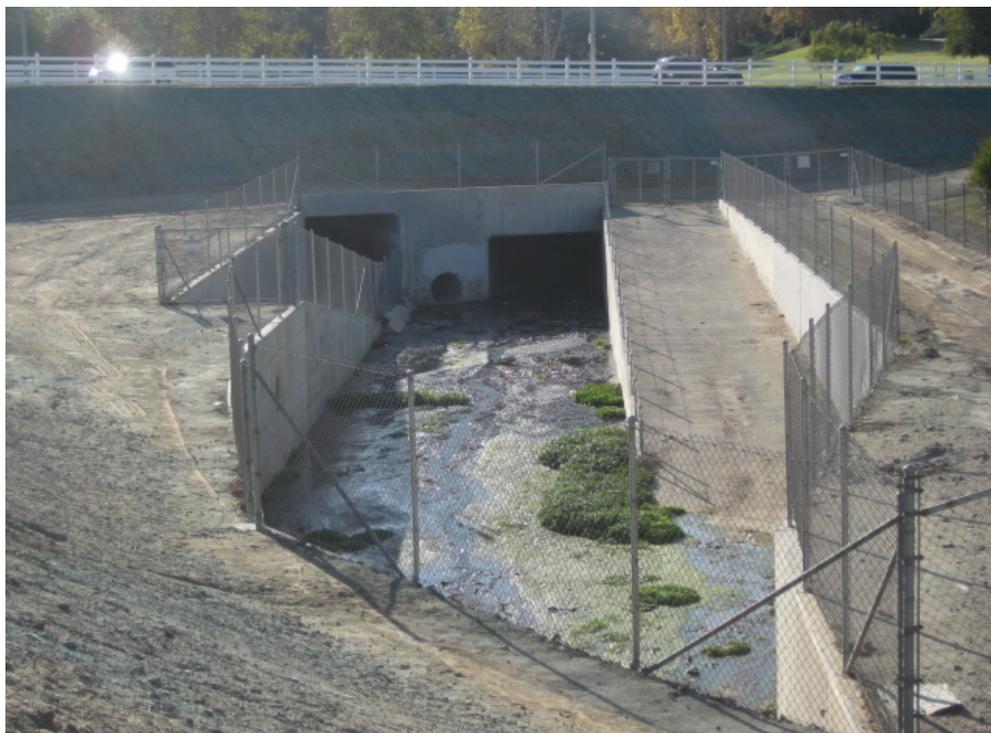
Figure 12. Upstream view of vertical concrete-lined channel north of Chino Hills Parkway, upstream of English Canyon Channel confluence

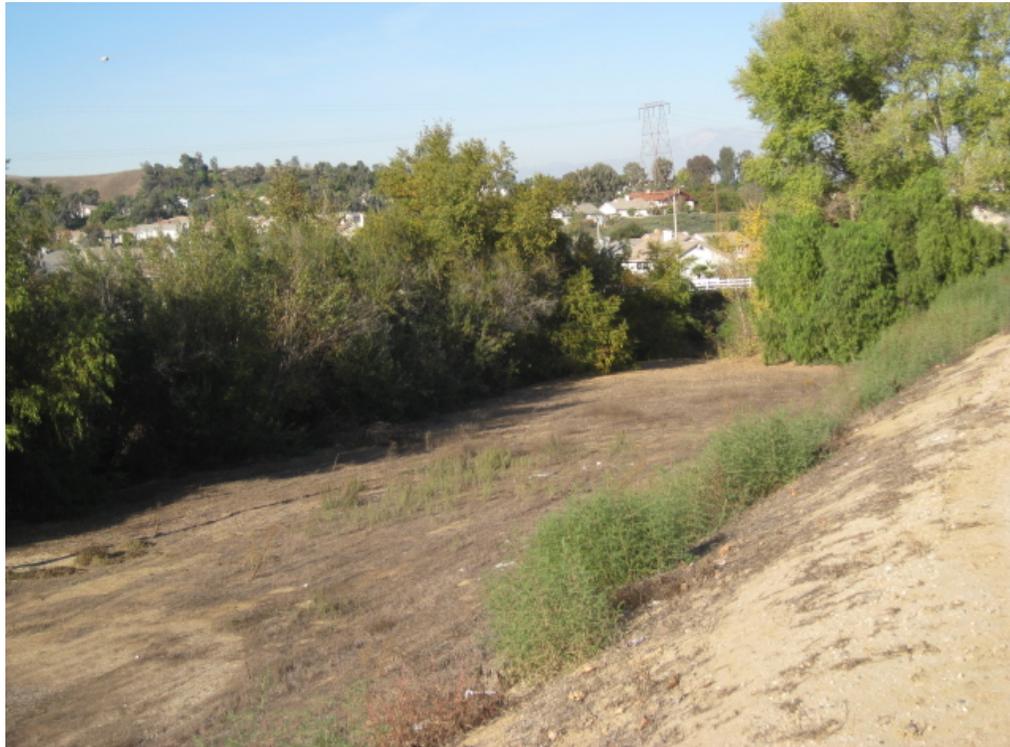
Figure 13. Downstream view of natural channel (within heavy vegetated area) in upper portion of the subwatershed, south of Chino Hills Parkway

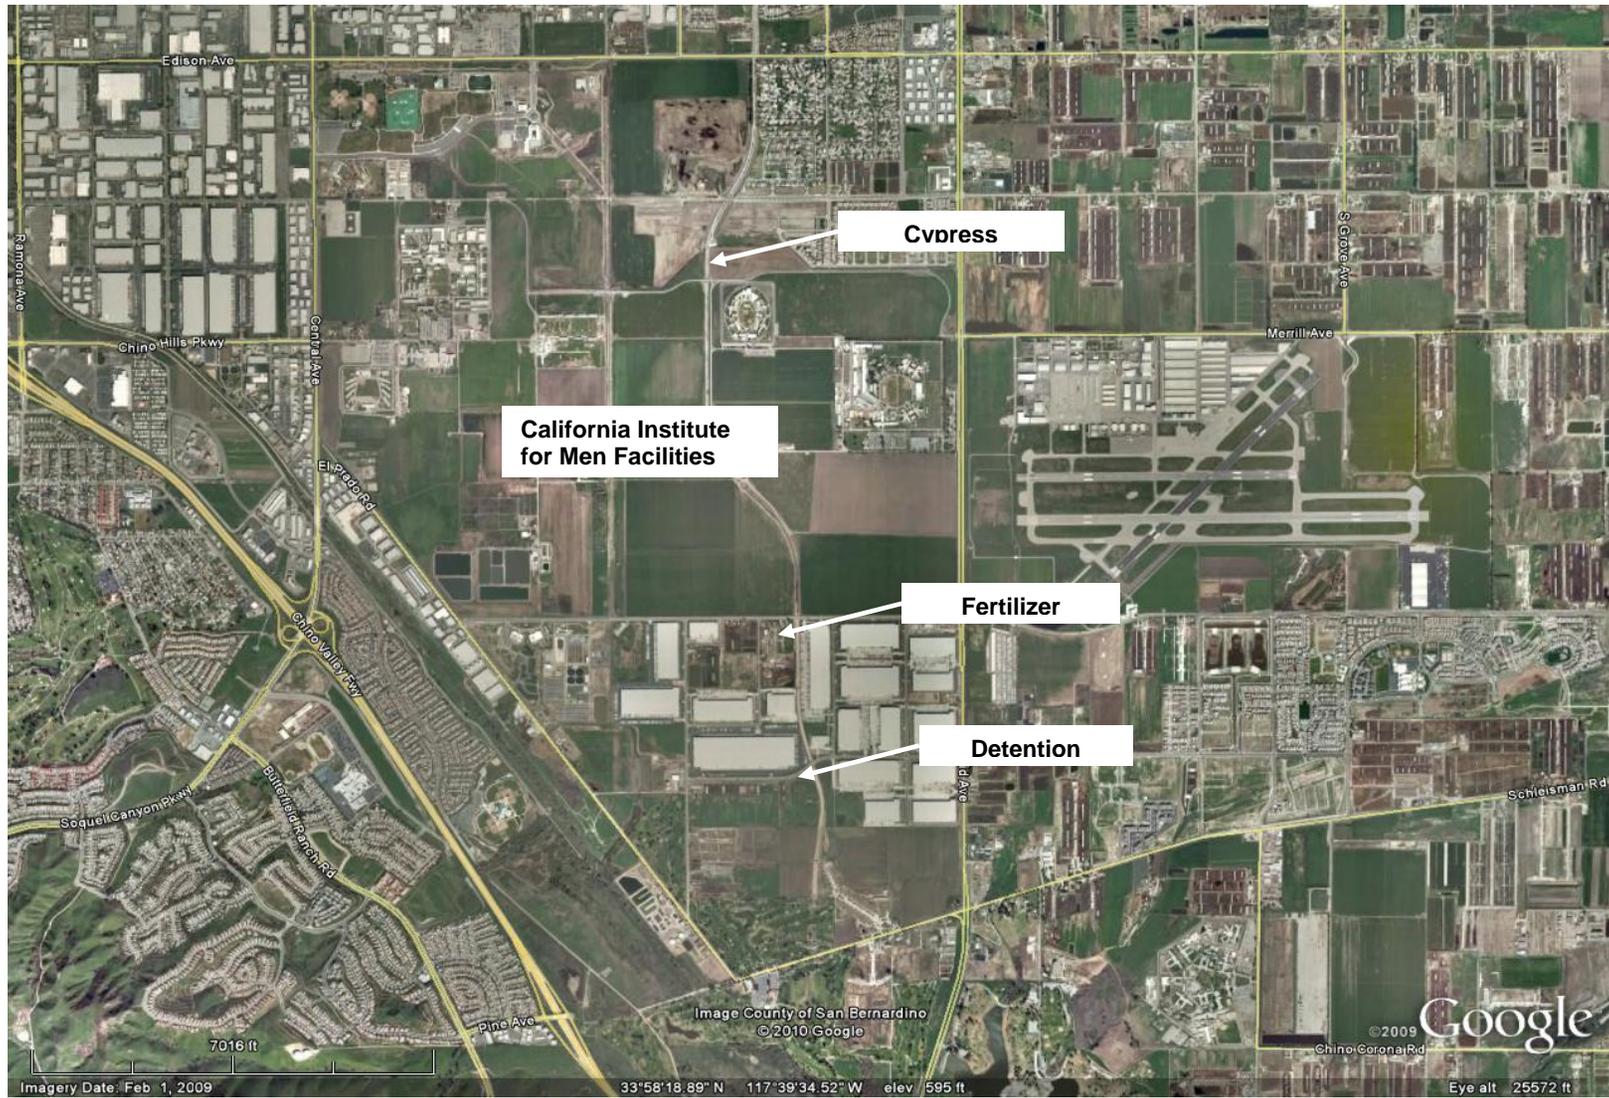
Figure 16. Aerial view of the lower part of the Cypress Channel subwatershed showing location of various facilities

A fertilizer facility is located southeast of Kimball Avenue and Cypress Channel, downstream of the USEP monitoring location (see Figure 16). During the field reconnaissance, CDM observed a stormwater storage basin within the property of the fertilizer plant (see Figures 27 through 31). A pipe and pumping system was set up adjacent to the basin. Water was being pumped from the storage basin to a smaller bermed holding pond that was located within the plant's property line but close to the SBCFCD right-of-way. No direct connections were made to the channel and no discharges were observed leaving the fertilizer plant property. A lateral pipe in the channel is connected to a flared end section located within SBCFCD right-of-way but adjacent to the pumping system (see Figure 29). The purpose of this pipe is unclear.

A detention basin designed to drain runoff from a commercial development is located downstream of Bickmore Avenue and Cypress Channel (also downstream of the USEP monitoring location, see Figure 16). This retention basin collects runoff from commercial properties located to the northwest of Bickmore Avenue and Cypress Channel. The detention basin, which was constructed as part of an approved Water Quality Management Plan, is believed to have been constructed in 2005 as part of the commercial/industrial development. The basin is designed to empty within 72 hours for vector control purposes (communication with Don Allinder, City of Chino, January 13, 2010). During the field survey, the basin was filled with water and actively discharging to Cypress Channel (Figures 32 and 33). Given the rain event the prior evening, this basin was operating as intended.

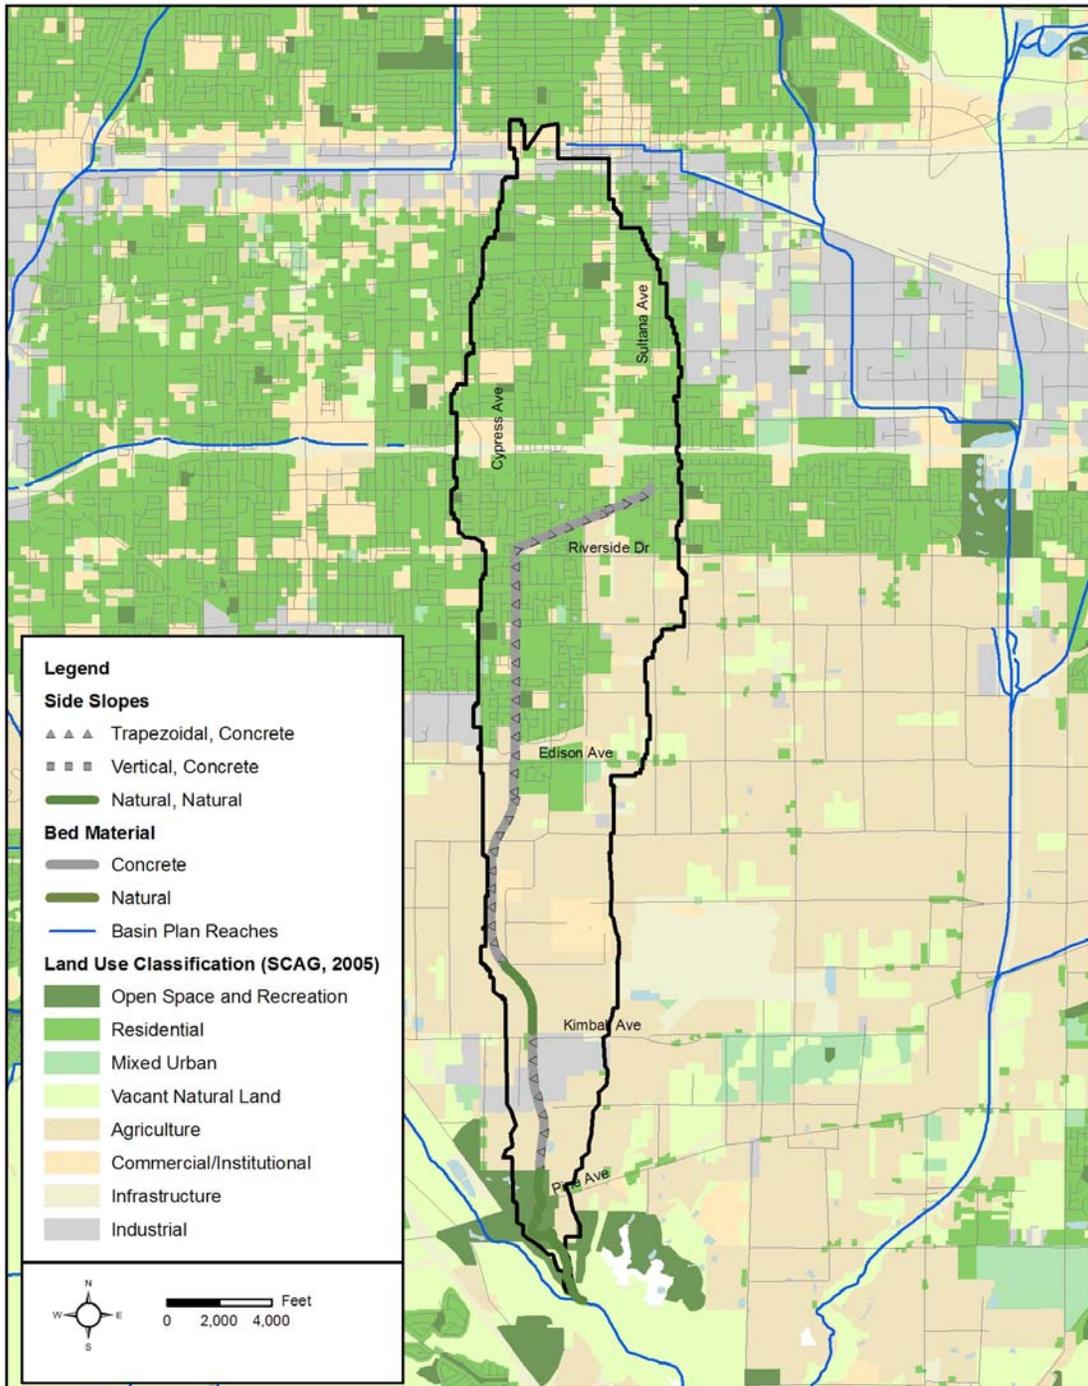
Figure 18. Cypress Channel characteristics

Table 7 describes the sidewall and bottom construction of the Cypress Channel. These channel attributes are mapped in Figure 18. Cypress Channel is predominantly a trapezoidal concrete-lined channel. Within the CIM right-of-way, the channel transitions to a natural unlined channel at approximately 3,000 feet north of Kimball Avenue; it then reverts to a trapezoidal concrete-lined channel downstream of Kimball Avenue. SBCFCD does not maintain nor have jurisdictional authority over any portion of the channel within CIM. This segment of the channel does not appear to be maintained. Agricultural fields are on both sides of the channel with no defined buffer to separate agricultural field operations from the unlined channel (see general location of CIM facilities in Figure 17; see photographs of channel in CIM area in Figures 19 and 20).

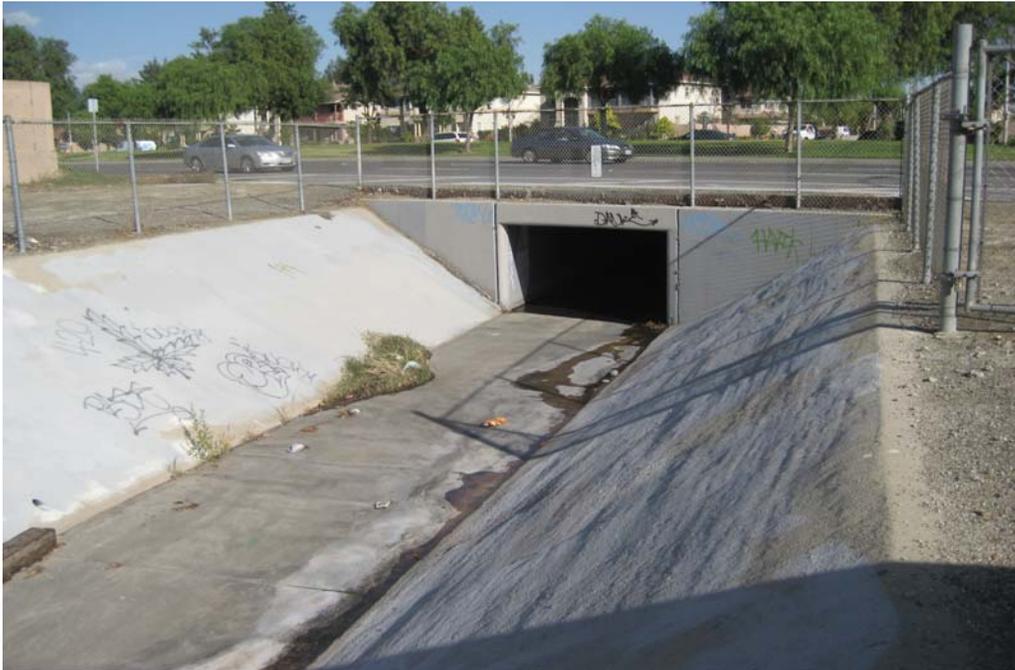
Figure 21. Upstream view of Cypress Channel at Euclid Avenue

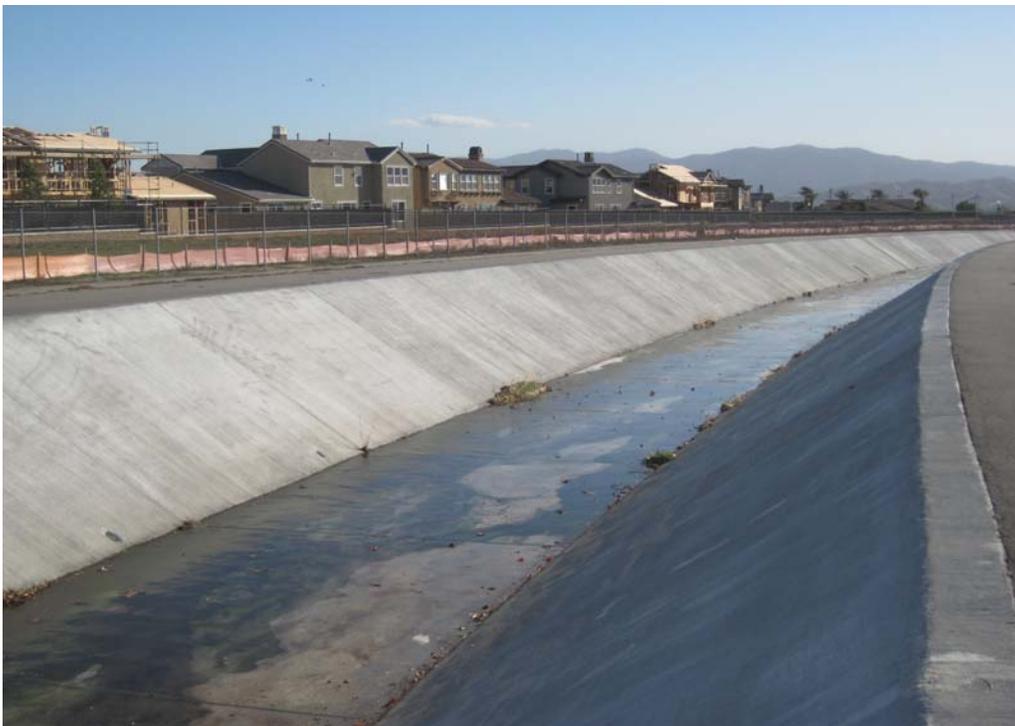
Figure 22. Downstream view of Cypress Channel north of Eucalyptus Avenue, adjacent to College Park housing development

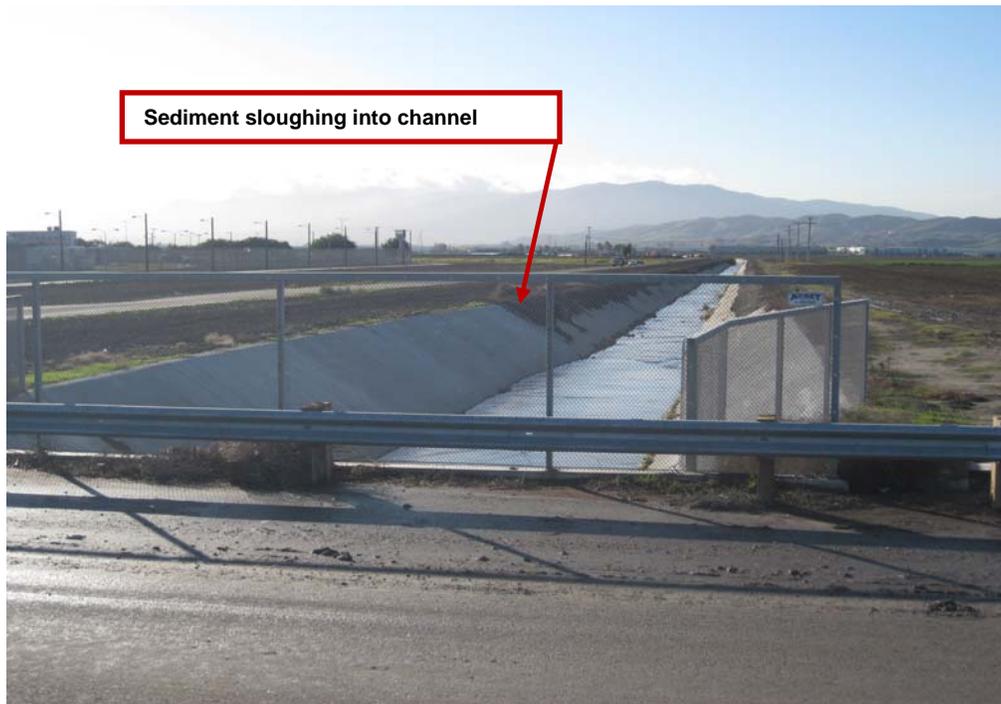
Figure 23. Downstream view of Cypress Channel within CIM property

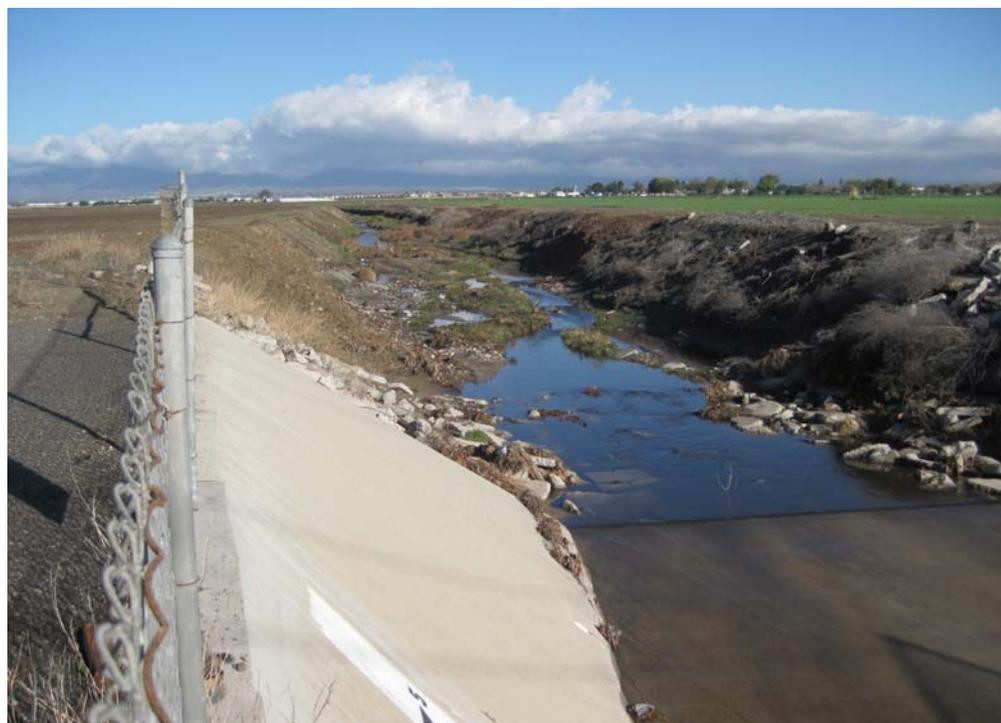
Figure 24. Upstream view of Cypress Channel at Kimball Avenue (transition from earthen to trapezoidal concrete channel)

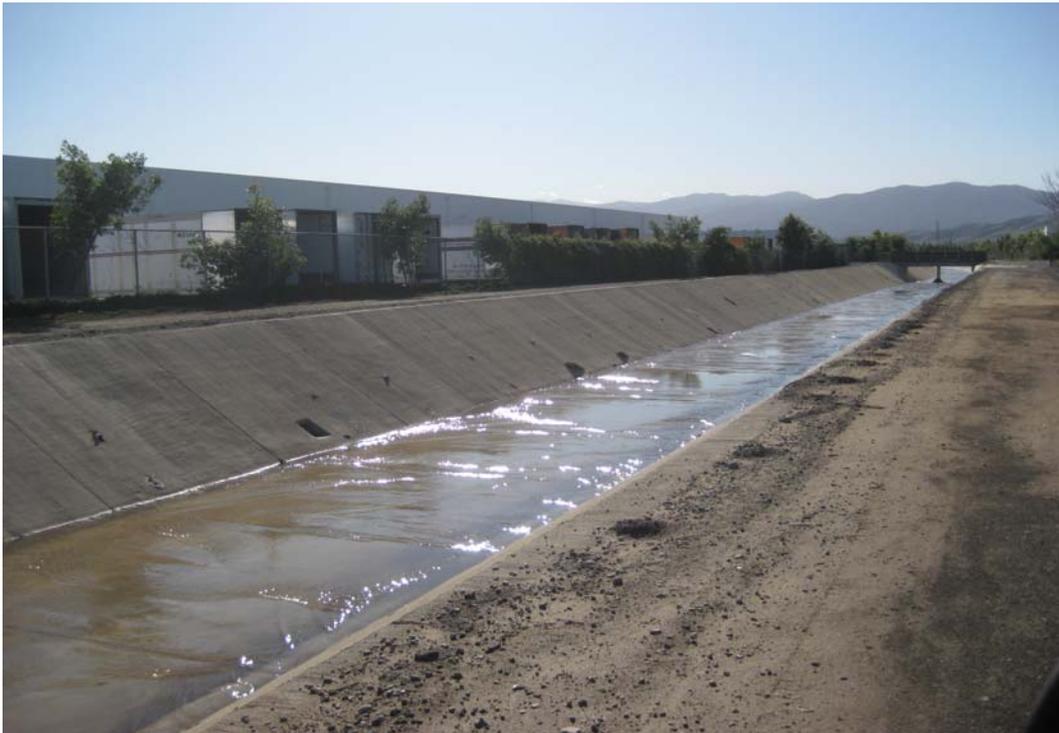
Figure 25. Downstream view of Cypress Channel below Kimball Avenue

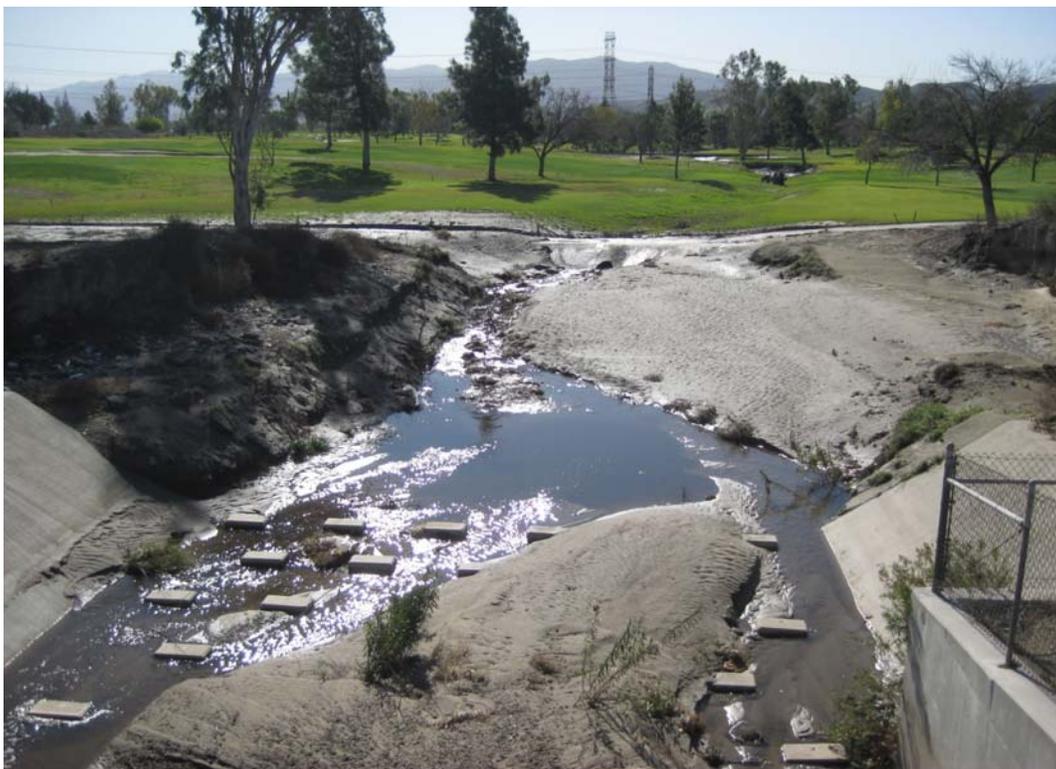
Figure 26. Downstream view of Cypress Channel as it enters the El Prado Golf Course
